King County
Department of
Natural Resources and Parks
Director's Office
King Street Center
201 S Jackson St, Suite 700
Seattle, WA 98104-3855

March 7, 2017

RE: West Point Restoration Schedule, Forensic Analysis and Independent Review

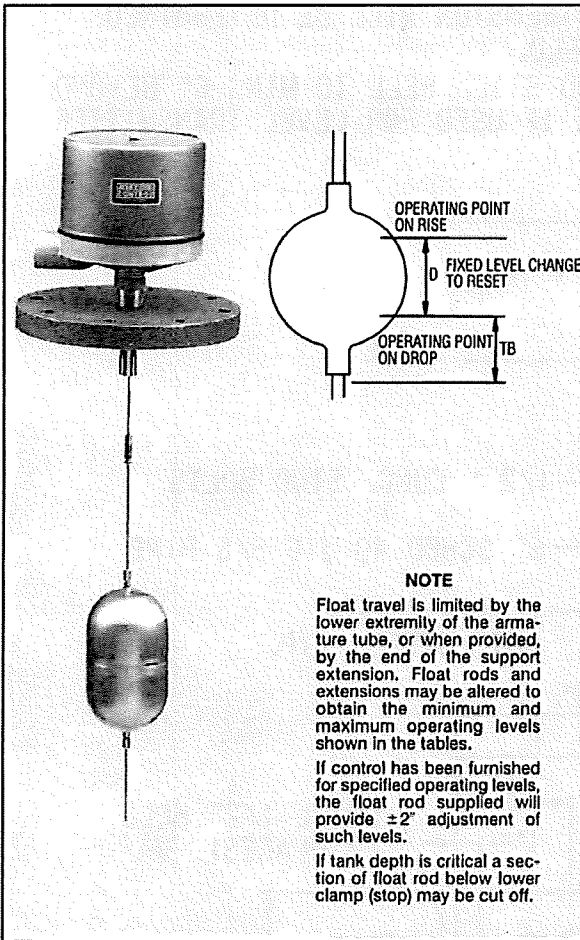
Series
301

These level sensors, or float switches, did not work. If they had worked properly, the flooding in the plant would not have happened. Based on our initial investigation, it appears that bends in the rods connecting the floats created friction which may have prevented the floats from working properly. The bends may have occurred during routine maintenance and testing of the floats. A diagram of these switches is attached.
