Subject: Slope Evaluation Revised Summary Letter  
Raging River Quarry 32715 Carmichael Road  
Fall City, Washington  
File No. 22534-001-01

Excavation Plan	
Raging River Quarry Fall City, Washington	
	Figure 2

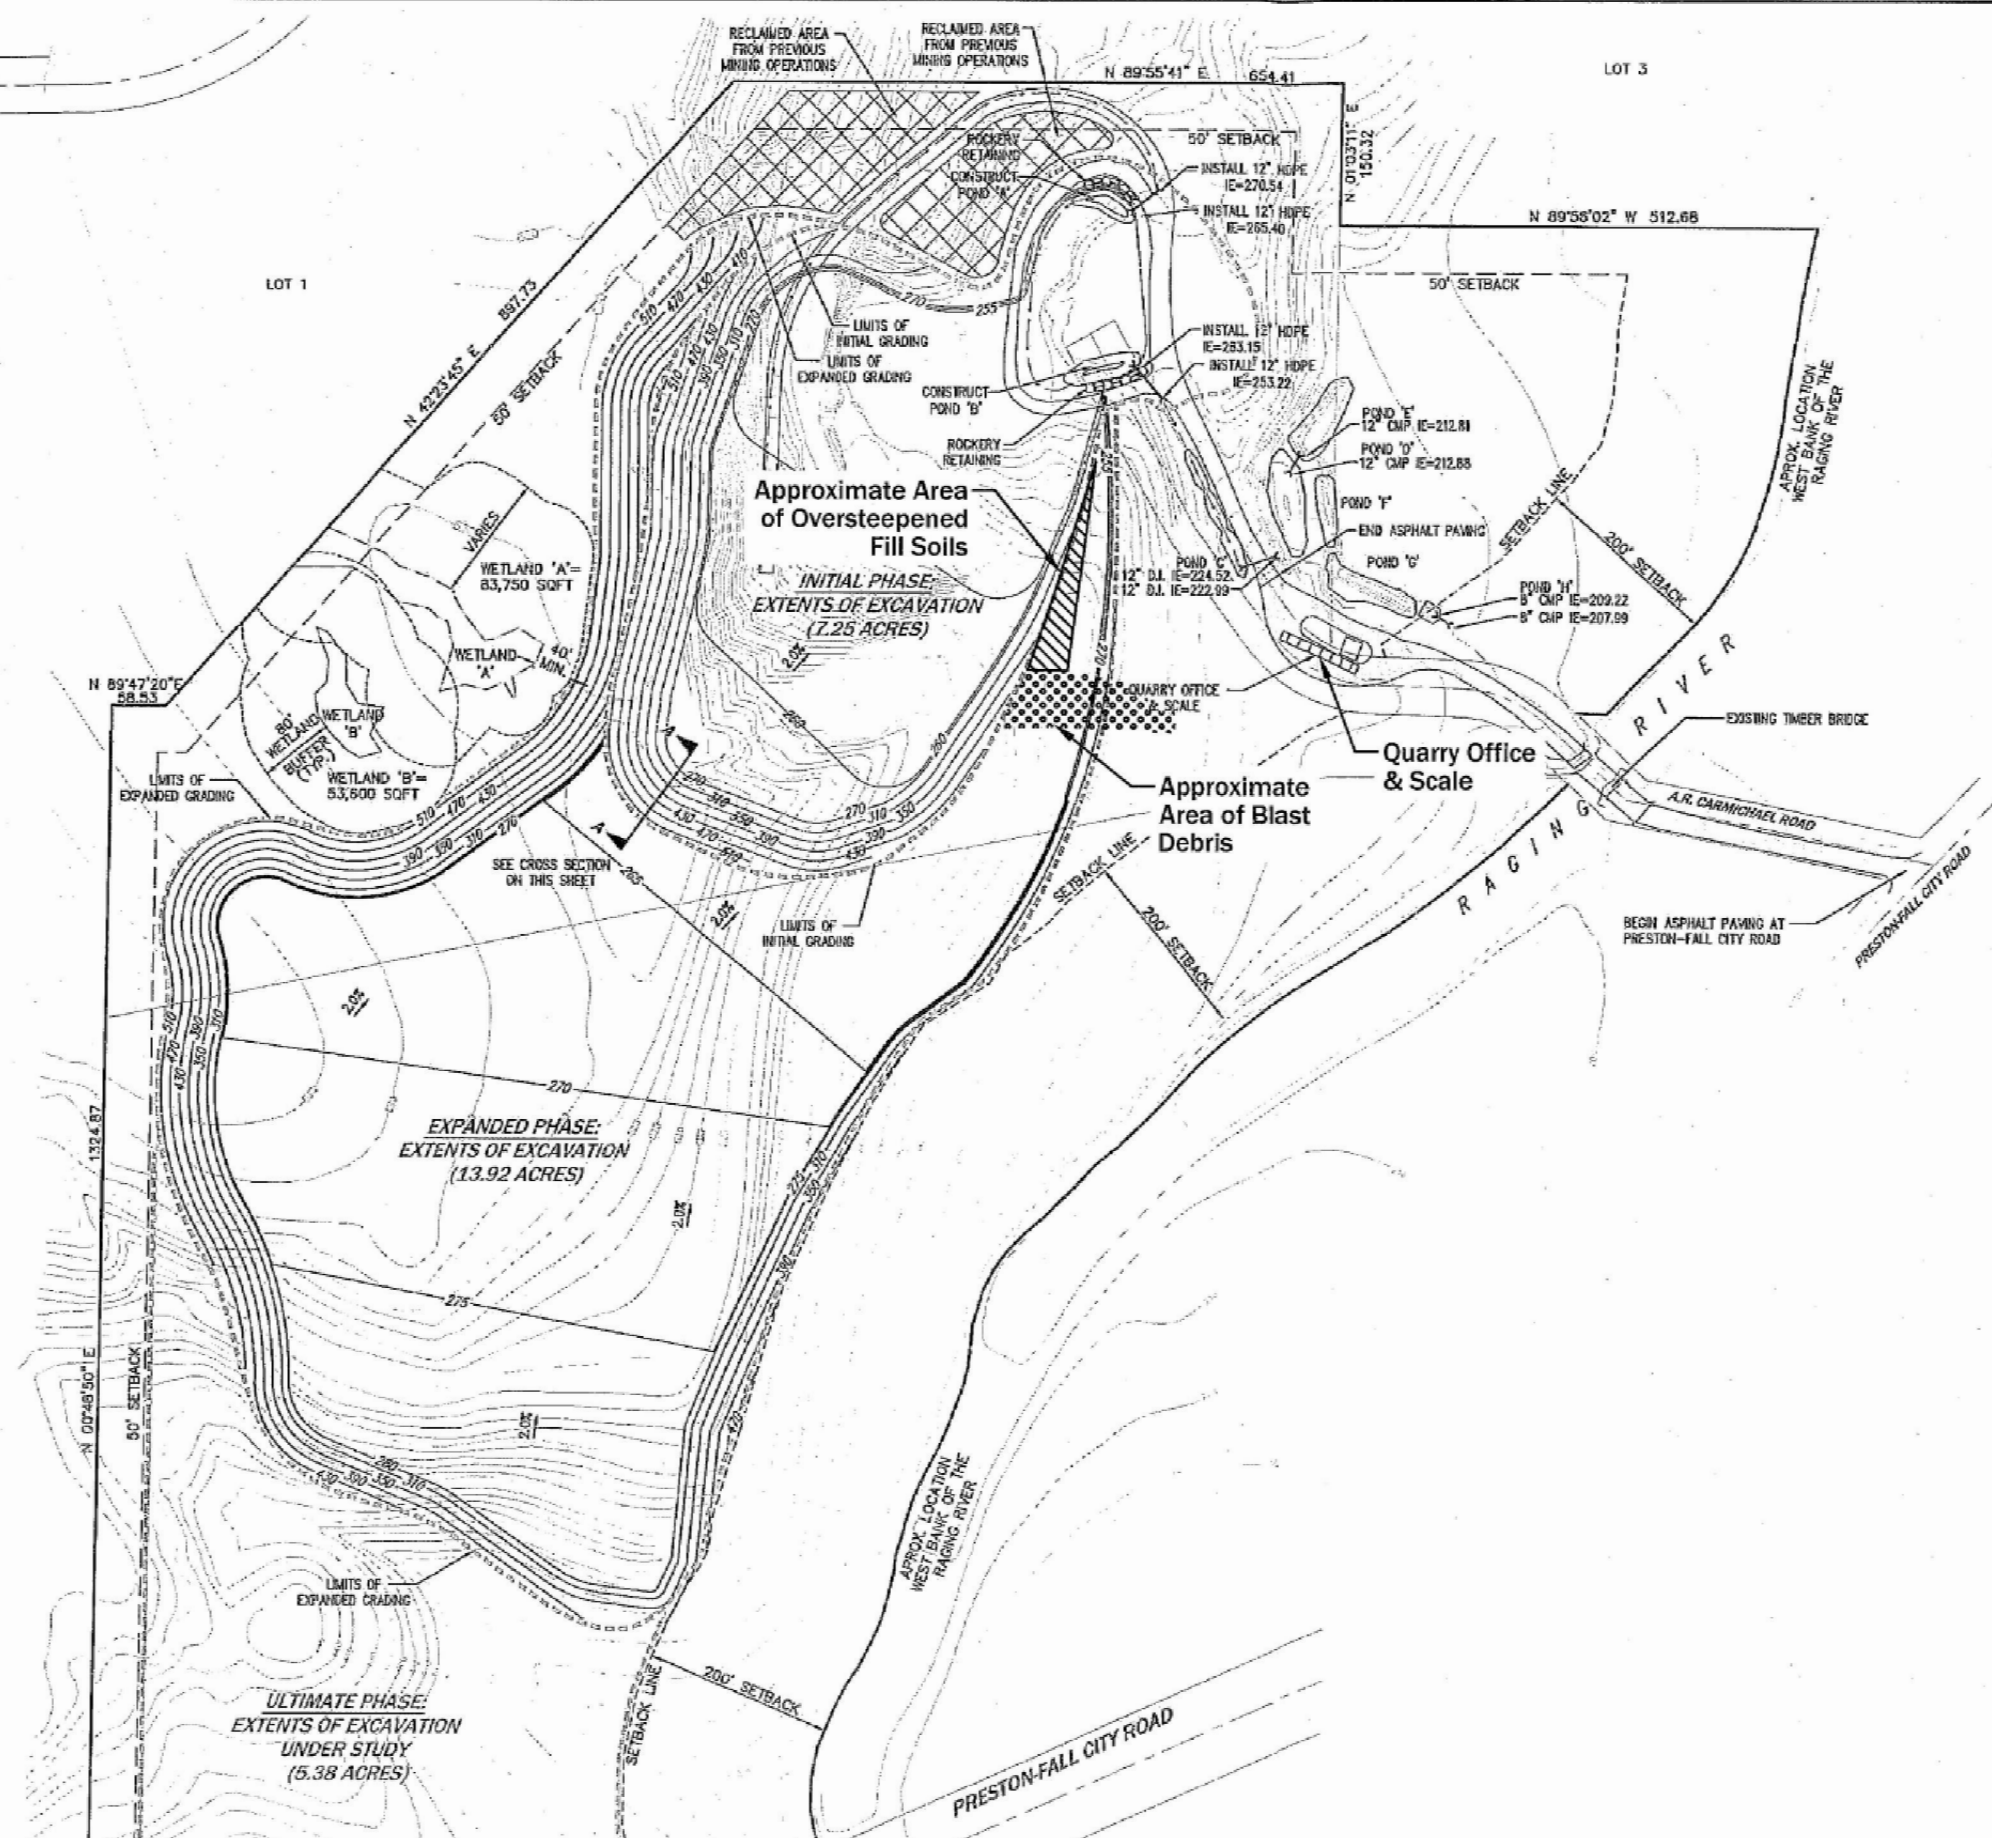
We also observed the area impacted by the July 27 shot. We observed blast debris that has apparently mobilized toward the toe of the slope as shown in Figure 2. In general, the debris includes sand, gravel, cobble and boulder sized fragments that are deposited onto the slope that is locally steeper than 70 percent. A number of conifer trees were knocked over by the blast debris. Two large blast debris angular blocks of rock were greater than 6 feet in diameter.

The area upslope of this flagging includes tailings/waste/fill soils in placed by Eastside Rock Products in May 2017 (Figure 2). The tailings consist of loose sand, silt and gravel (glacial gravel deposits) from overburden that appeared to have been locally compacted with an excavator bucket on the face and near the top of the slope. In other places, the fill soils appeared to have been end-dumped and were in a loose, uncompacted condition. The fill gradients exceed 70 percent locally. The thickness of the fill soils upslope of the 300-foot elevation ranges from approximately 5 to greater than 20 feet locally.

It is our opinion that blasting activities on July 27, 2017 were too close to the face of the slope. It is also our opinion that the oversteepened fill soils are at risk of erosion and potential failure during the upcoming wet season. Prior to the wet season (October 1) we recommend that Eastside:

1. Reduce the slope gradient of the tailings/waste/fill soils upslope of Elevation 300 to a 2 Horizontal :1 Vertical (50 percent) slope. Alternatively, a steeper slope could be designed with a mechanically stabilize earth (MSE) wall that includes a series of compacted lifts built up with a geo-grid or other equivalent material, and a coir fabric facing. This would require laboratory testing of the tailings/waste/fill soils for appropriate engineering design of the MSE wall.

2. During the regrade of the oversteepened fill recommended above, we also recommend removal of loose debris (gravel, cobble and boulder size debris) that can be safely retrieved by an excavator from the area up and downslope of Elevation 300 to reduce the risk of instability.
