Revised Report
Geotechnical Engineering Services
Ravensdale Reclamation Trench Filling and
Restoration Project
Ravensdale LLC Property
Section 1, T21N, R6E and Section 36, T22N, R6E
Ravensdale Area, King County, Washington

July 28, 2020
ICE File No. 1352-001

**Prepared For:
Ravensdale LLC**

**Prepared By:
Icicle Creek Engineers, Inc.**

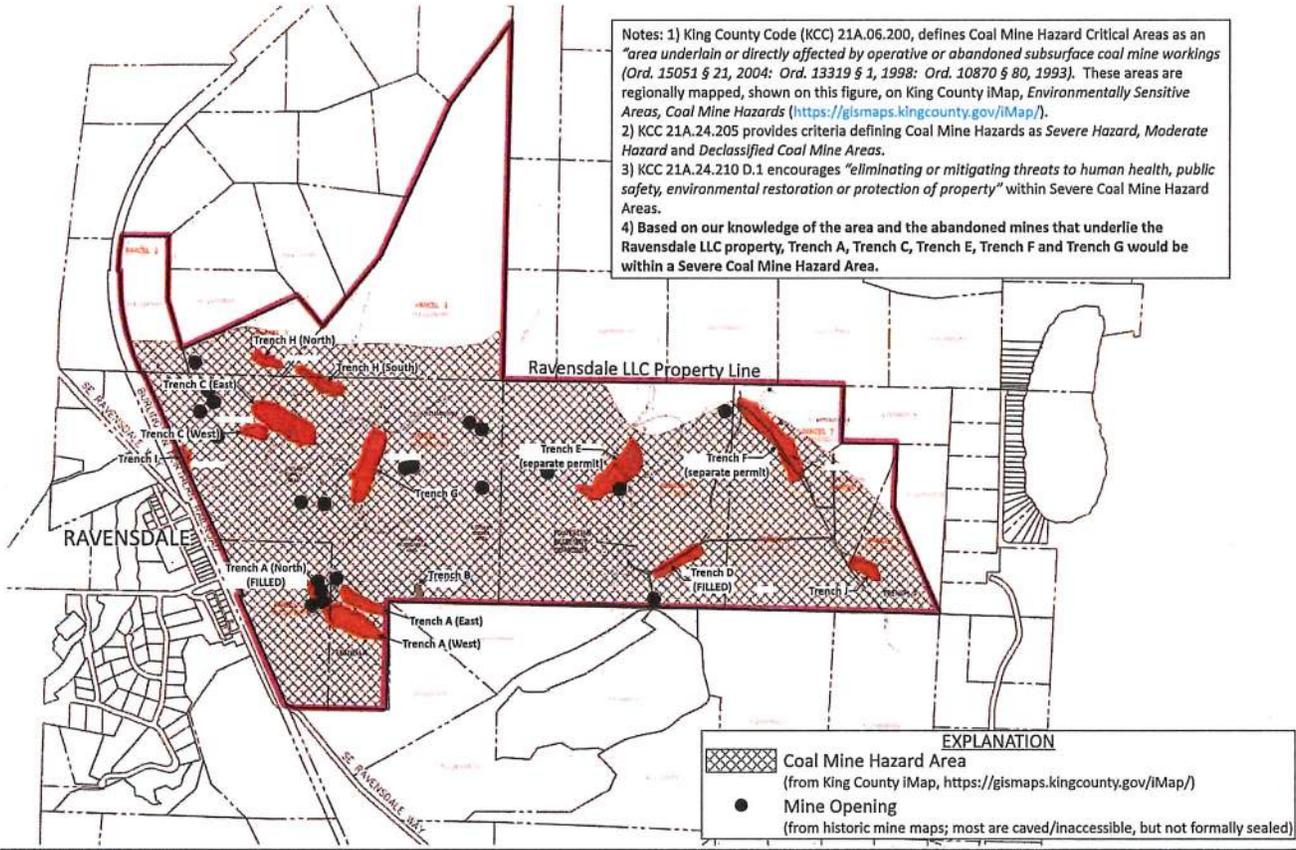
COAL MINE HAZARDS MAP
RAVENSDALE RECLAMATION TRENCH FILLING AND RESTORATION PROJECT
RAVENSDALE AREA, KING COUNTY, WASHINGTON

Based on our knowledge of the Ravensdale LLC Property area and the abandoned surface mines, Trenches A, C and G are within a Severe Coal Mine Hazard Area. Trenches B, H, I and J are located within the regional Coal Mine Hazard Area; based on available information, it is not known if abandoned underground coal mines underlie these areas. A Severe Coal Mine Hazard is defined by Ordinance 13319 *as unmitigated openings such as entries, portals, adits, mine shafts, air shafts, timber shafts, sinkholes, improperly filled sink holes, and other areas of past or significant probability for catastrophic ground surface collapse. Severe coal mine hazard areas typically include, but are not limited to, over land surfaces underlain or directly affected by abandoned coal mine workings from a depth of zero (i.e. surface of the land) to one hundred fifty feet.*

4) Based on our knowledge of the area and the abandoned mines that underlie the Ravensdale LLC property, Trench A, Trench C, Trench E, Trench F and Trench G would be within a Severe Coal Mine Hazard Area.

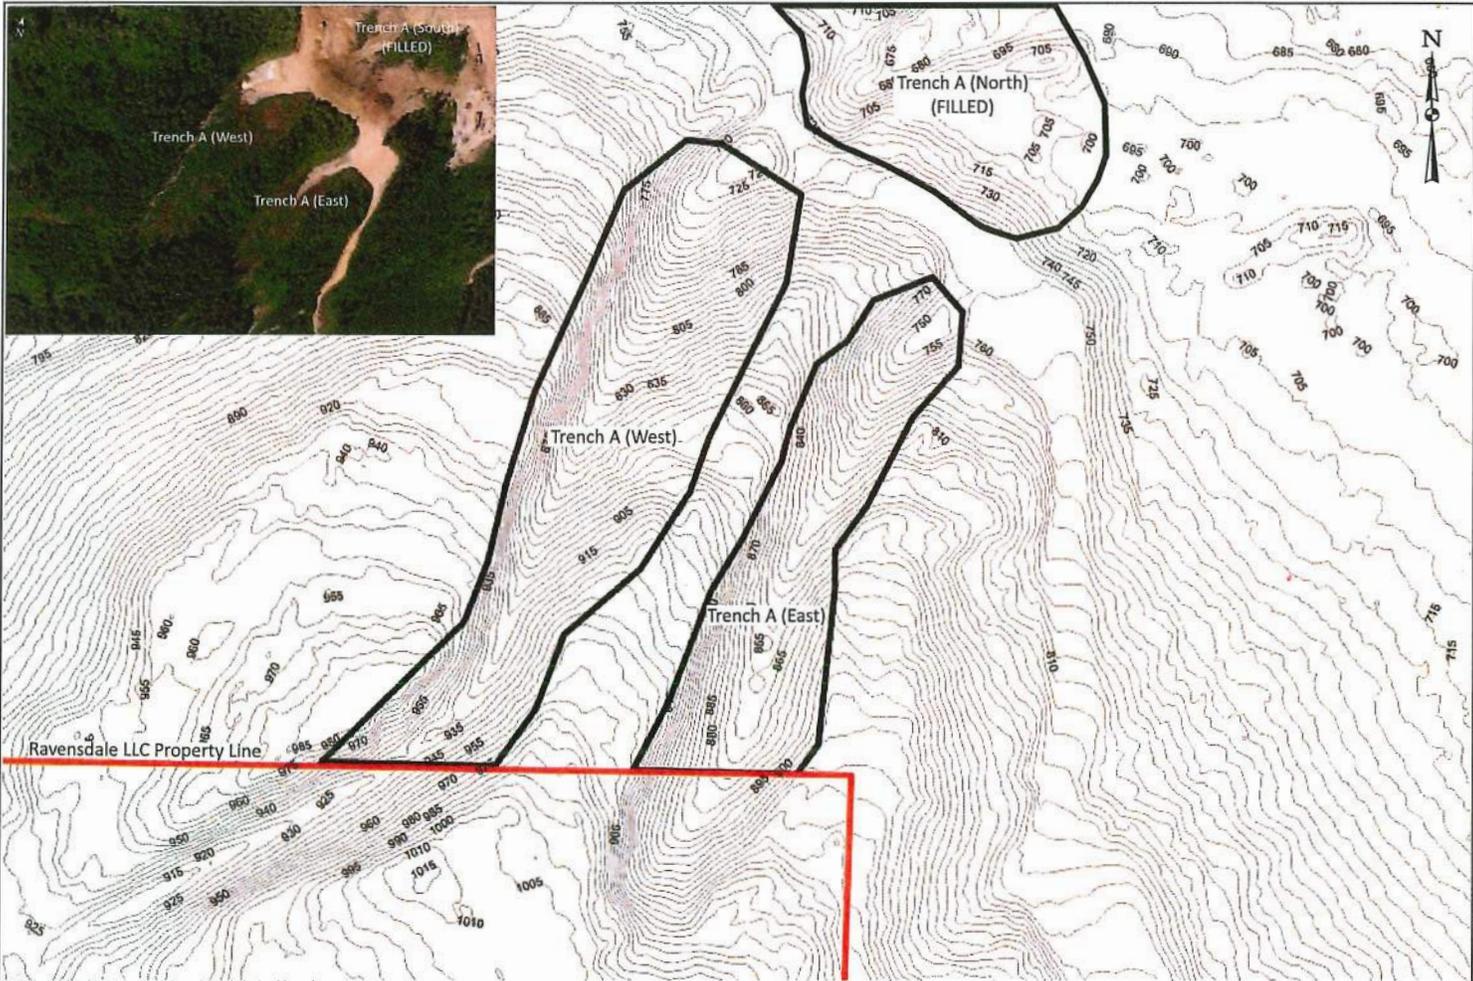
SCALE: As Shown	ICE FILE NO.
DESIGNED BY: —	1352-001
DRAWN BY: MBP	
CHECKED: KSK	Figure
DATE: 07/28/20	4

Trench A (West) – Trench A (West) as shown on Figure 4 is an open-ended, relatively steep/deep slot in the hillside that extends to the south property line. The sidewalls are near vertical on the west side, and near 100 percent grade on the east side. The base of the slot has scattered blackberry and other invasive plants and bare bedrock; no surface water was observed.

Trench A (East) – Trench A (East) as shown on Figure 4 is similar to Trench A (West) as an open-ended, relatively steep/deep slot in the hillside that extends to the south property line. The sidewalls are near vertical on the west side, and near 100 percent grade on the east side. The base of the slot has scattered blackberry and other invasive plants and bare bedrock; no surface water was observed.

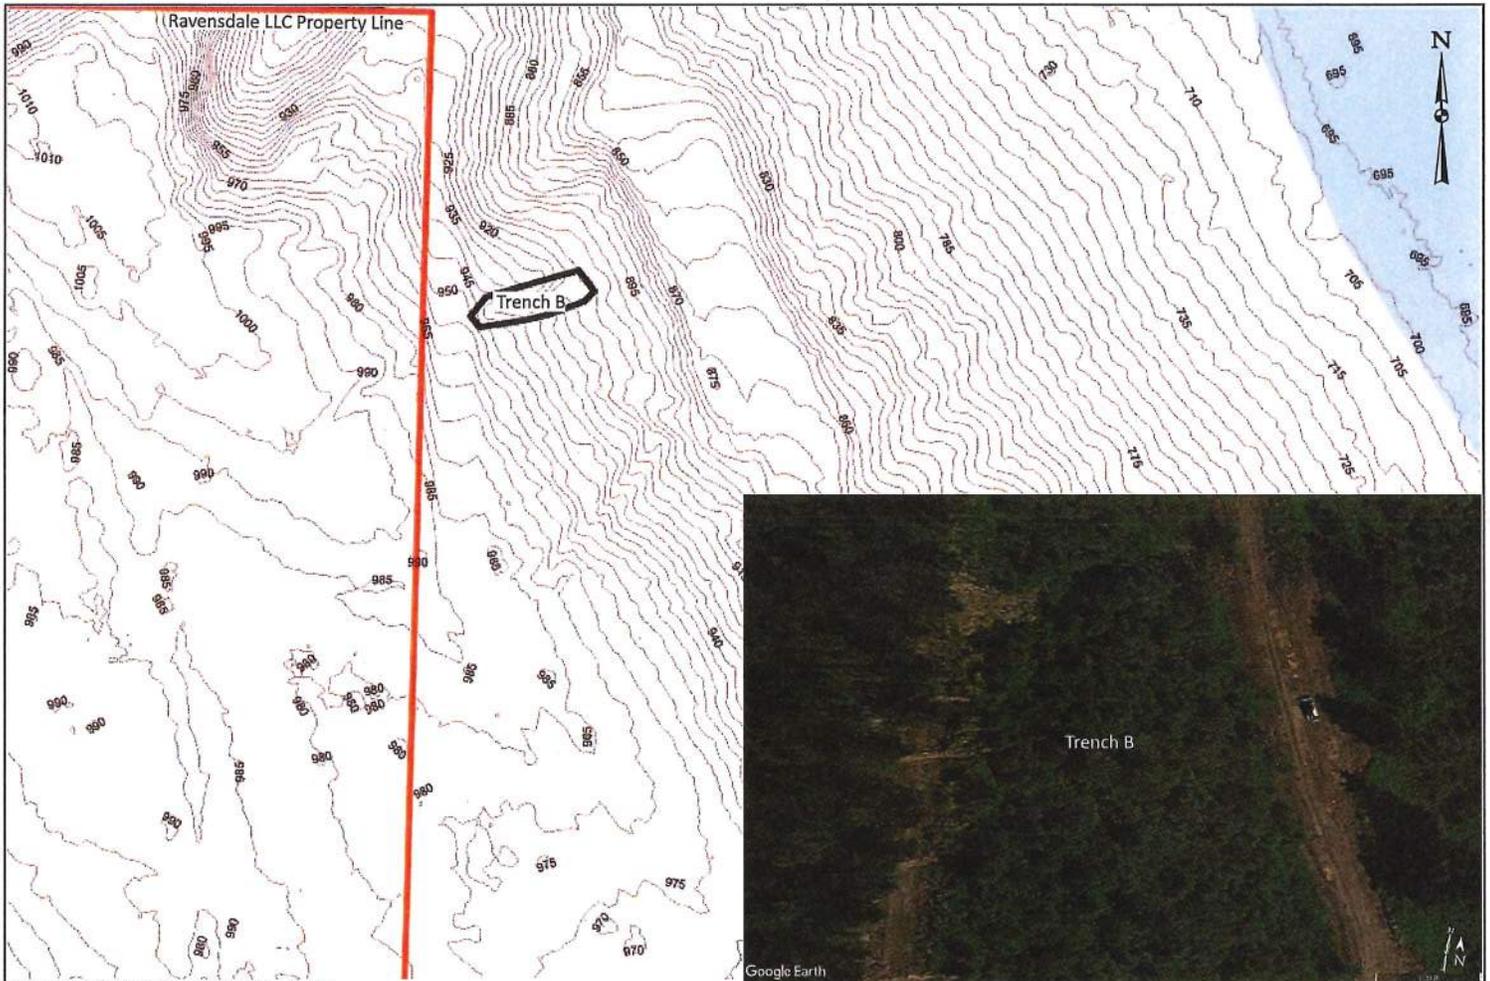
SCALE: As Shown	ICE FILE NO.
DESIGNED: ---	1352-001
DRAWN: BJB	Figure
CHECKED: NIK	5
DATE: 07/26/20

Trench B – Trench B (formerly referred to as Trench K) as shown on Figure 5 is very shallow (less than 5-foot deep) and occurs on a very steep hillside covered with dense brush. We expect that because of the very steep site conditions and small area that Trench B will be filled.
