Appendix G - Hazardous Materials Survey

HAZARDOUS MATERIALS SURVEY FINAL REPORT

HAZARDOUS MATERIALS SURVEY

**FACTORIA TRANSFER STATION IMPROVEMENTS
BELLEVUE, WASHINGTON**

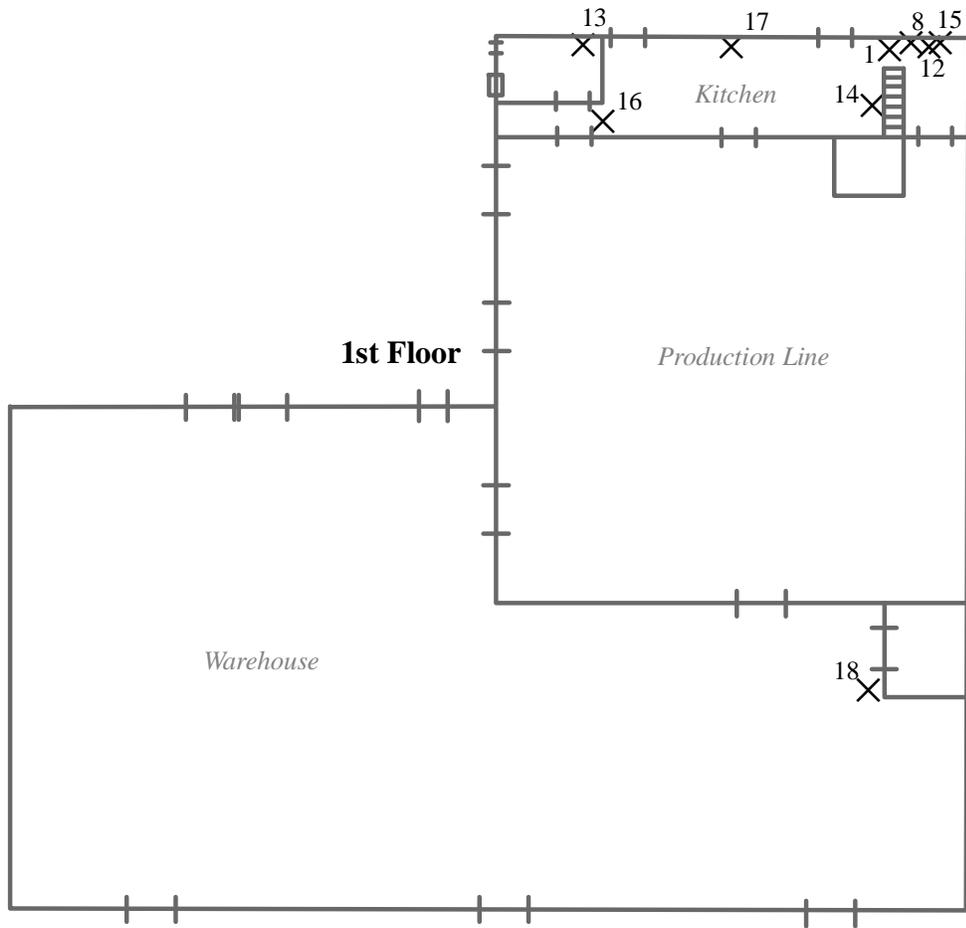
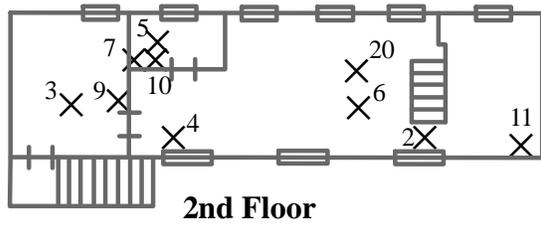
Figure 1

Tables 4-1 and **4-2** below summarize the suspect ACM and LBP samples that were collected and the analytical laboratory results. As seen from **Table 4-1**, ACMs were not identified in samples collected from the Clarisonic facility. As seen from **Table 4-2**, LBP was not detected above 0.5% by weight in the samples collected from the Clarisonic facility. It should be noted LBP is reported qualitatively as “Lead Present” in sample WH1-LBP-8 since the laboratory did not have sufficient material for analysis. However, sample WH1-LBP-8 was collected from a similar material and substrate as WH1-LBP-6 (dark blue painted metal door frame) and is believed to have a similar lead concentration (0.05%).

**13433 SE 30th St.
ACM sample locations**

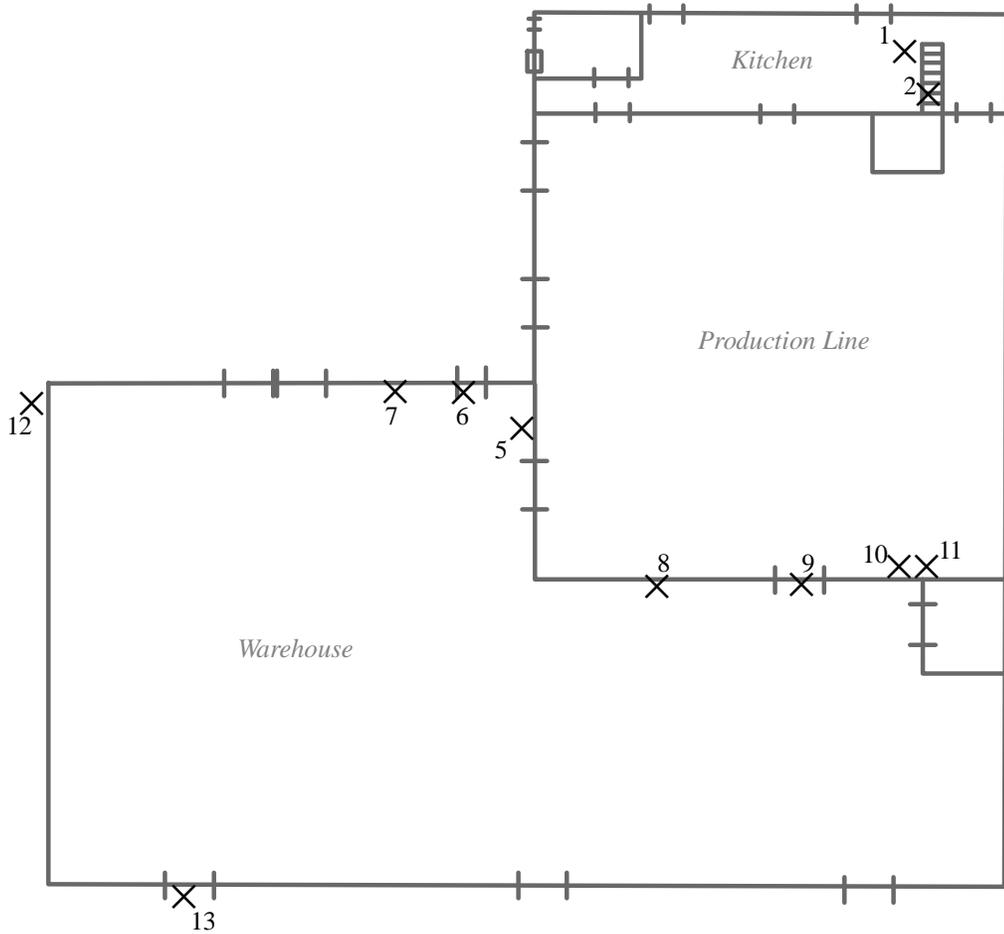
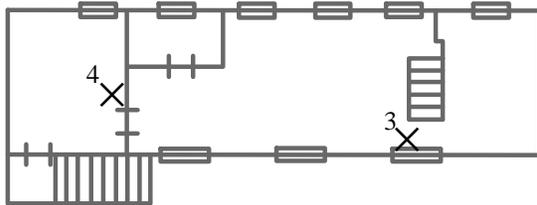
Figure 2

**13433 SE 30th St.
LBP sample locations**

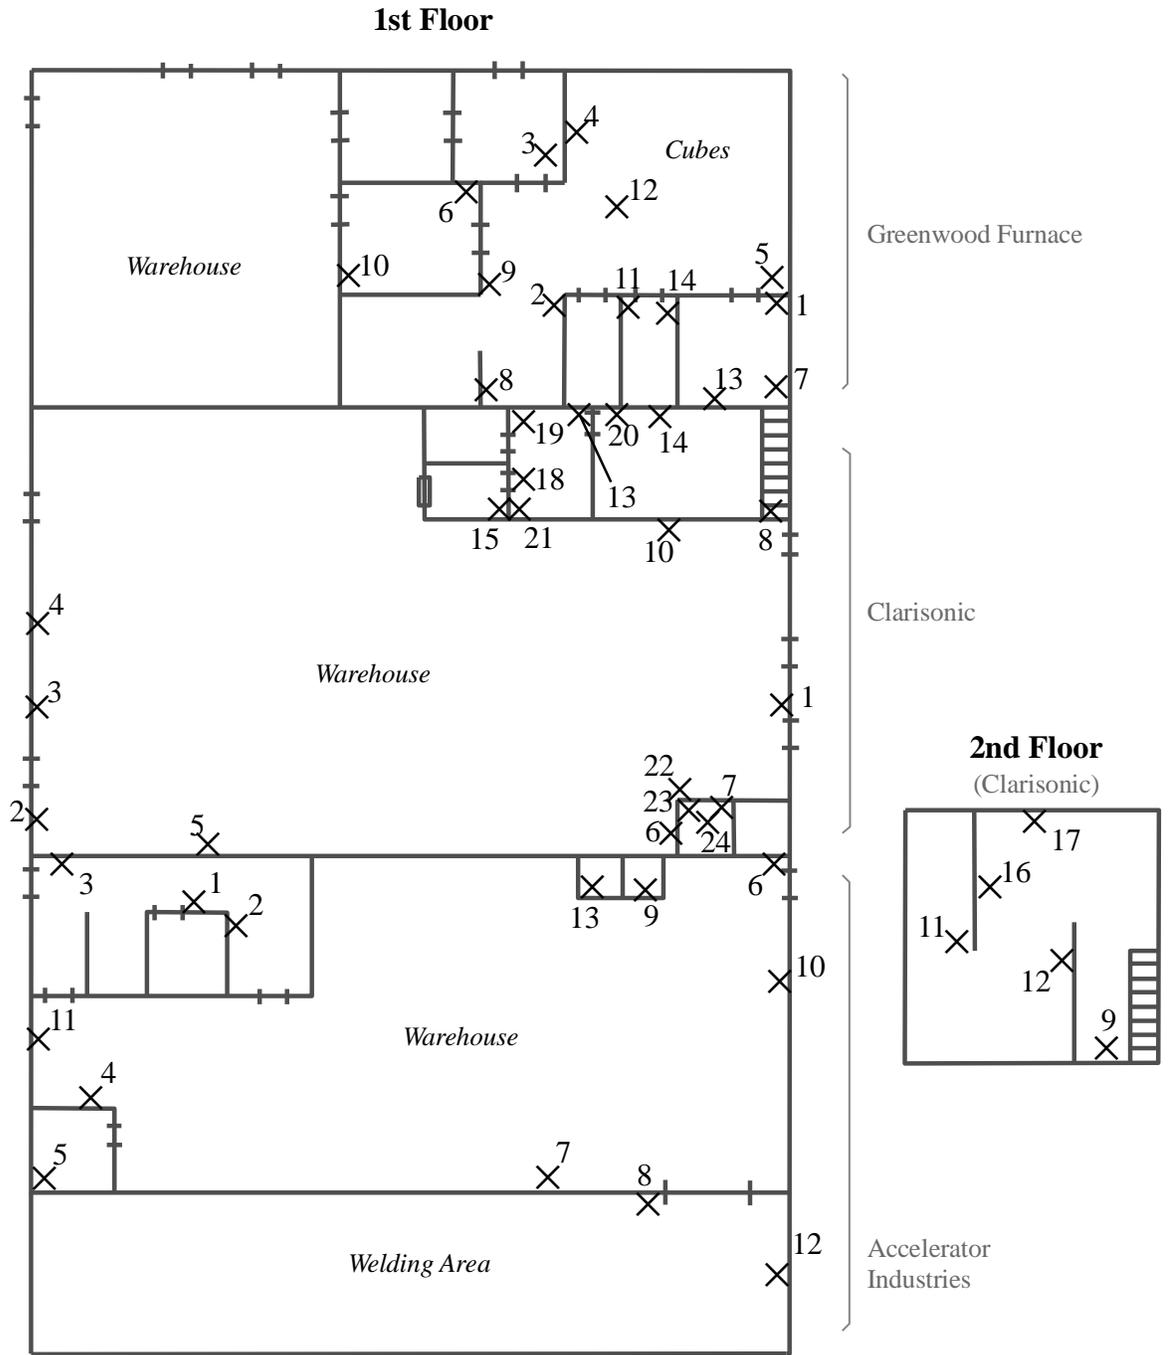
Figure 3

13429 SE 30th St.
ACM sample locations

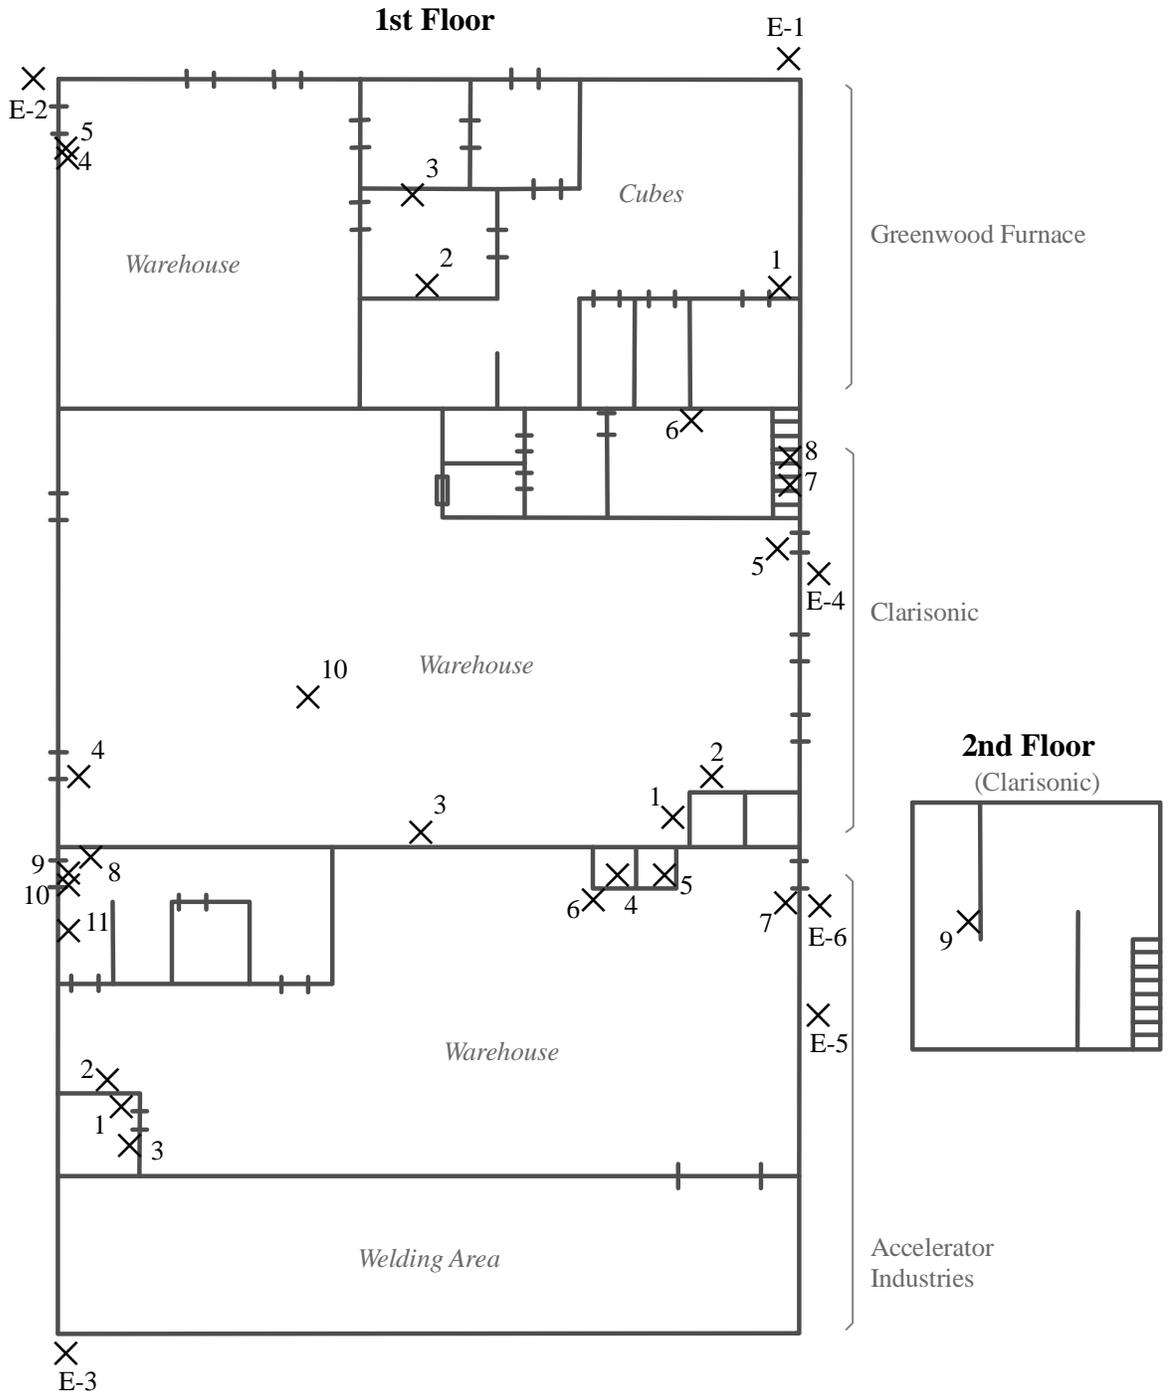
Figure 4

As seen from **Table 4-3**, LBP was not detected above 0.5% by weight in the samples collected from the exterior of the building. It should be noted LBP is reported qualitatively as “Lead Present” in sample WH2-LBP-3 since the laboratory did not have sufficient material for analysis. However, sample WH2-LBP-3 was collected from a similar material and substrate as WH2-LBP-5 (yellow painted sheet metal) and is believed to have a similar lead concentration (0.03%).

13429 SE 30th St.
LBP sample locations

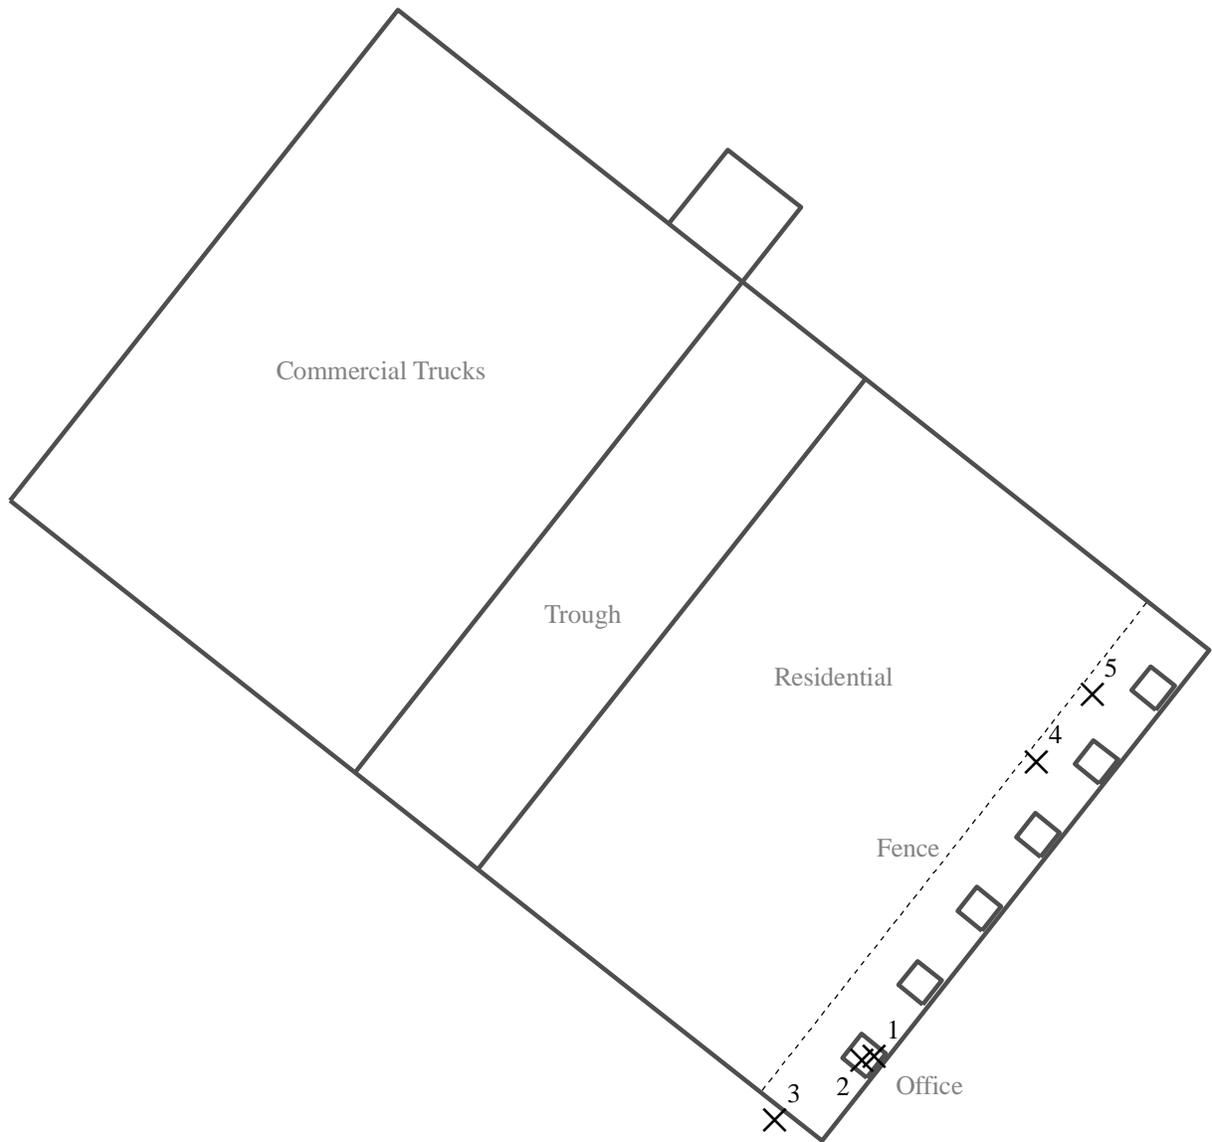
Figure 5

**Transfer Station
ACM sample locations**

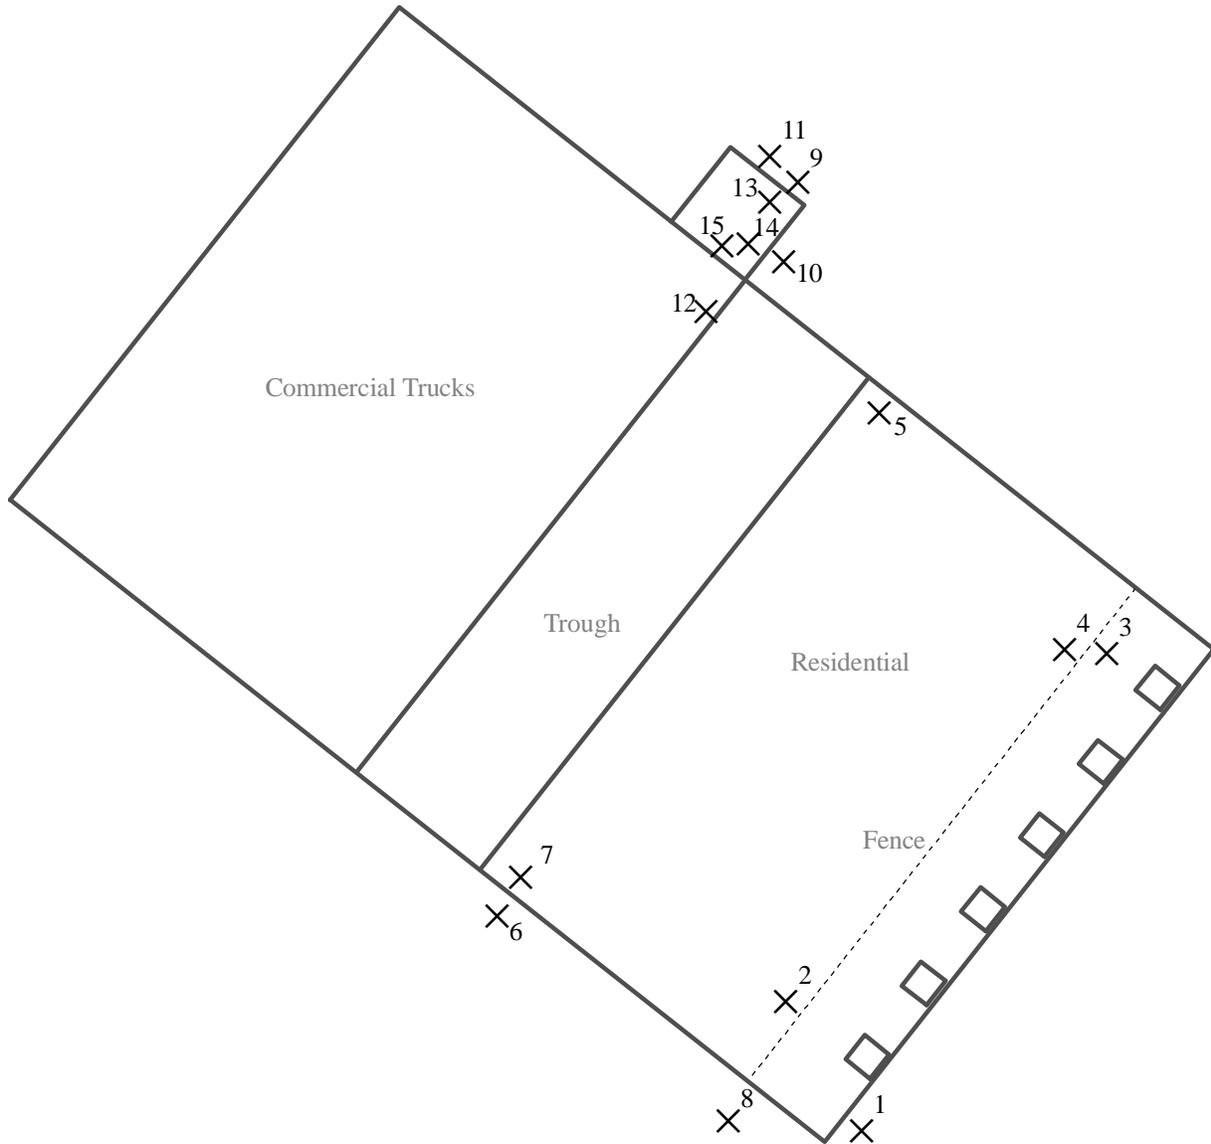
Figure 6

Sample #	Location (Main Transfer Station Building)	Material	Condition	Estimated Quantity (Total)	LBP (%)
TS-LBP-02	HHW	Safety bollard below metal pillar, yellow on concrete	Fair to poor	300 ft sq	6.9
TS-LBP-03	HHW	Support pillar, silver spray paint over red on metal	Fair to poor	1,000 ft sq	1.6
TS-LBP-05	Residential Bays	Northeast support pillar, white over red on metal	Fair to poor	1,000 ft sq	0.74

Sample #	Location (Main Transfer Station Building)	Material	Condition	Estimated Quantity (Total)	LBP (%)
TS-LBP-06	Exterior	Southwest end between bays, white on metal	Fair to poor	6,000 ft sq	1.4

Transfer Station LBP sample location

According to the Washington Department of Commerce Lead-Based Paint Program, abatement of the LBP before demolition is not necessary. However, if any LBP abatement or demolition activities are to take place, they must conform with OSHA Lead in Construction regulations found in 29 CFR Part 1926.62, which require the employer provide worker protection. In addition, the waste stream will need to be analyzed for hazardous characteristics (lead) by Toxicity Characteristic Leaching Procedure (TCLP) prior to disposal to determine if it is a hazardous waste.

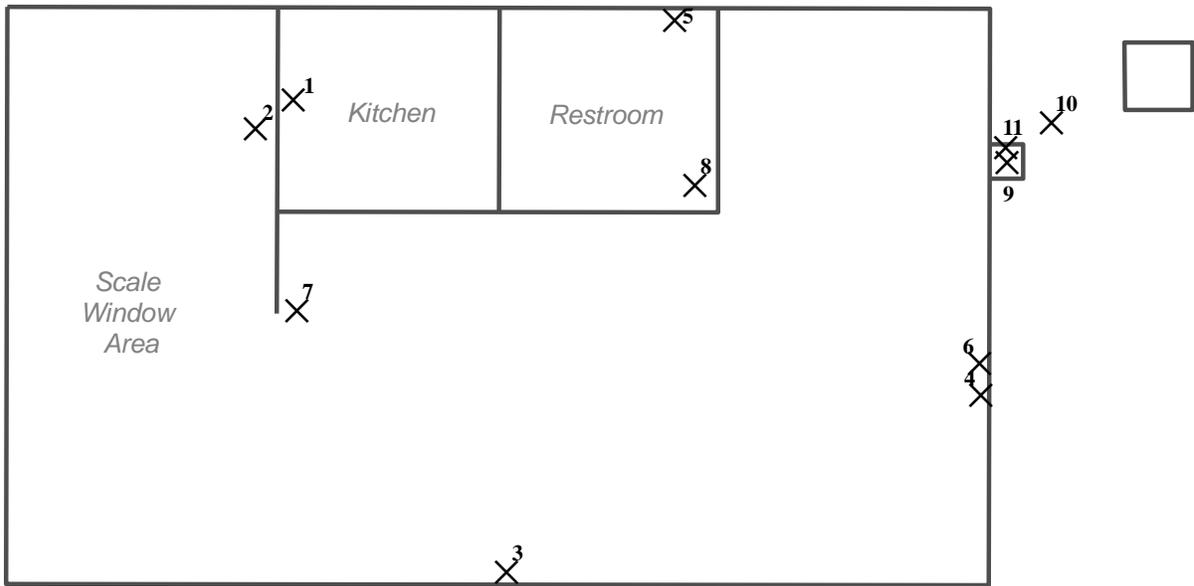
Figure 7

Scale House ACM sample locations

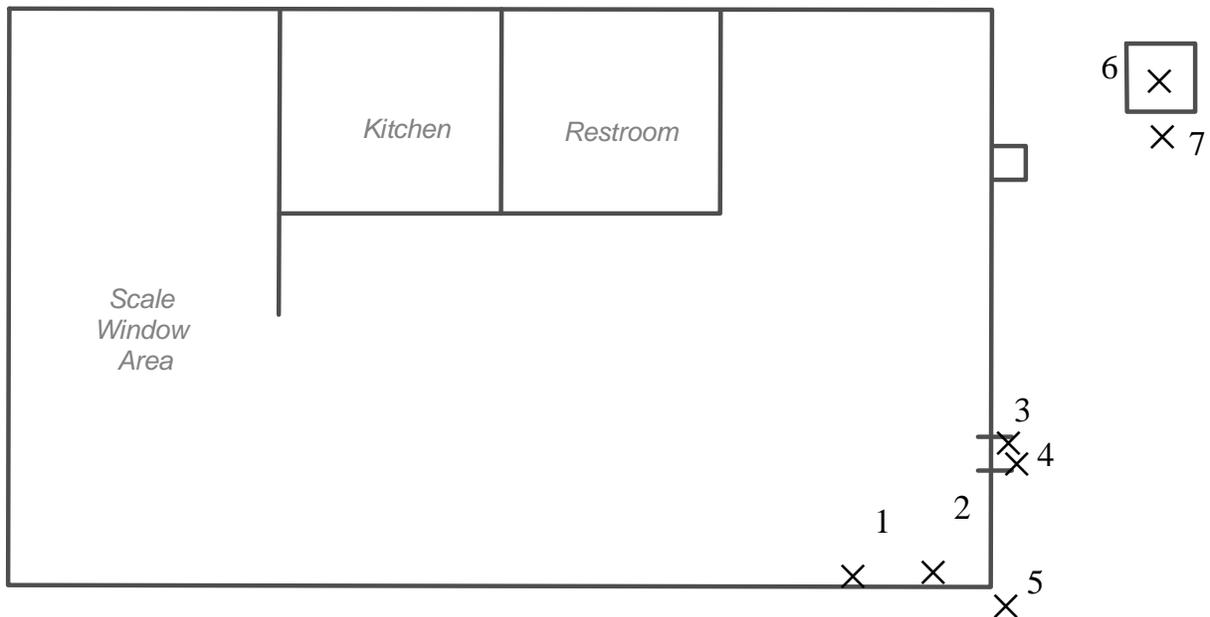
Figure 8

**Scale House
LBP sample locations**
