MAGNOLIA

PIPE REPAIR PROJECT

King County
Department of Natural Resources and Parks
Wastewater Treatment Division

Damaged Pipe Investigation Summary

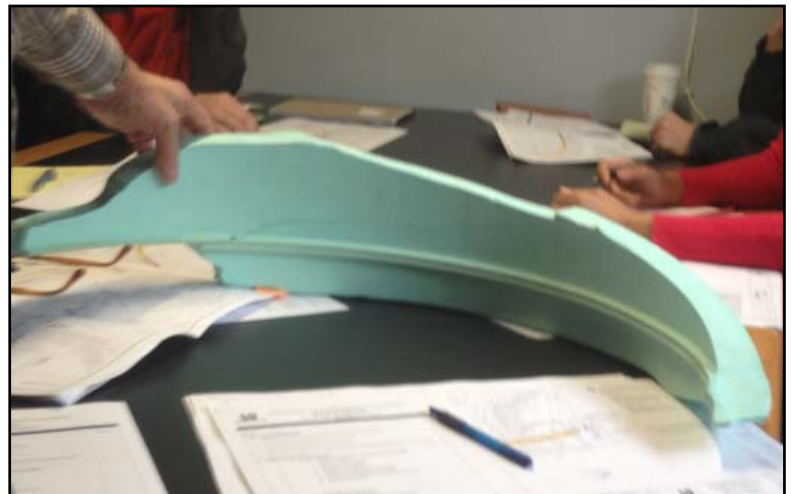
King County confirmed the pipe was broken in November 2016 when pieces of the pipe drained into the storage tank near Smith Cove. The debris suggested the pipe broke at a joint. The County mobilized its project contractor for a rapid response to stabilize the area around the pipe and find the exact location of the break.

Pipe debris found in the storage tank indicated the pipe broke at a joint, so drilling inspections focused on joint locations

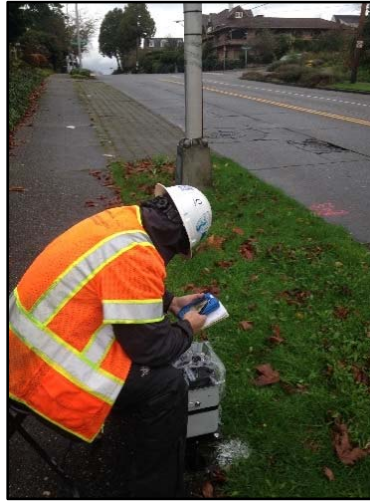
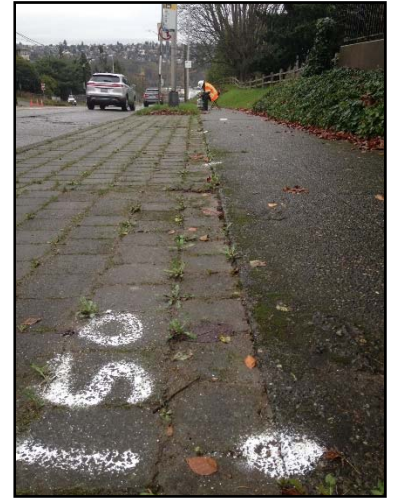
Crews began drilling 6-inch holes in the soils above the pipe to locate areas of soil loss. Crews injected cementitious grout in any area of soil loss they found.

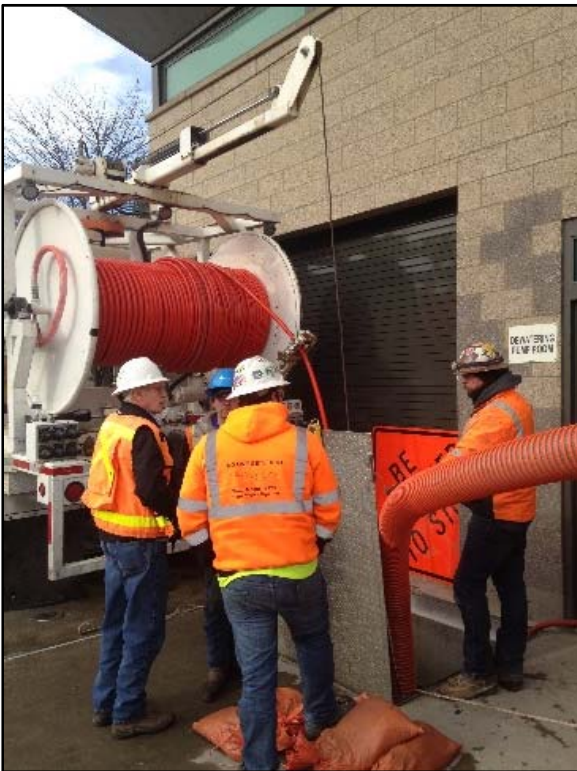
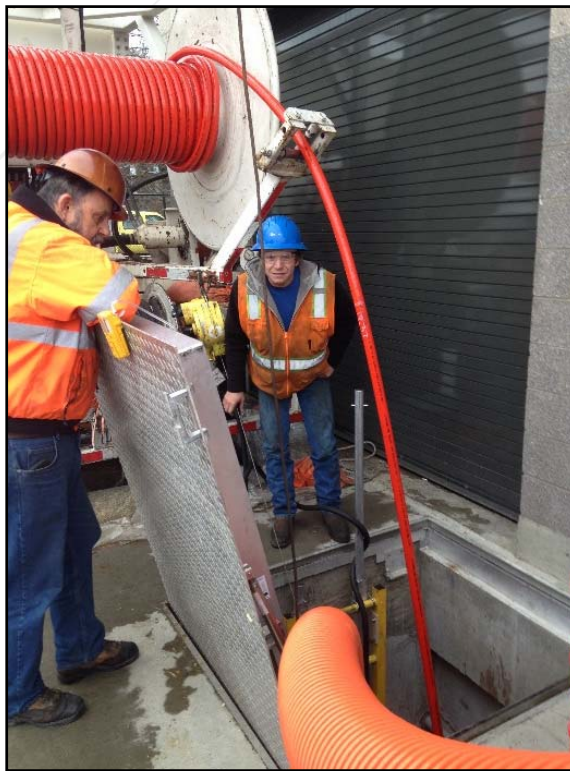
Tomographic surveyors mapped underground conditions around the broken pipe.

Crews found the pipe break location while attempting to clean the pipe out from the Magnolia Wet Weather Station.

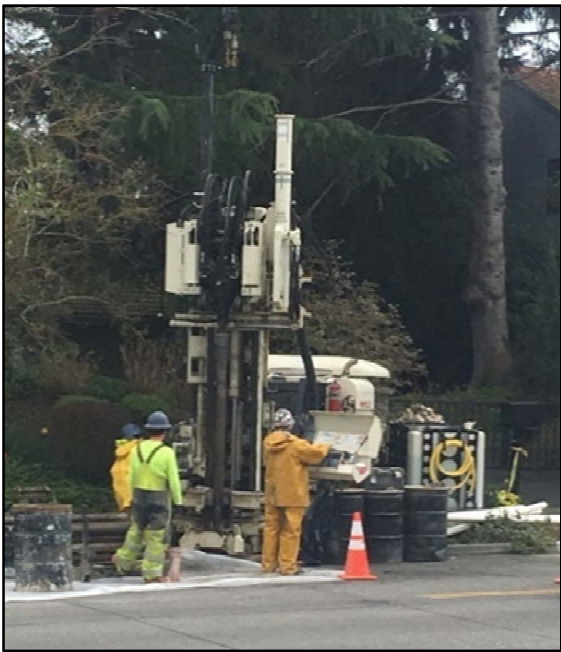
Drilling and grouting stabilized the area along the pipe under West Galer Street.

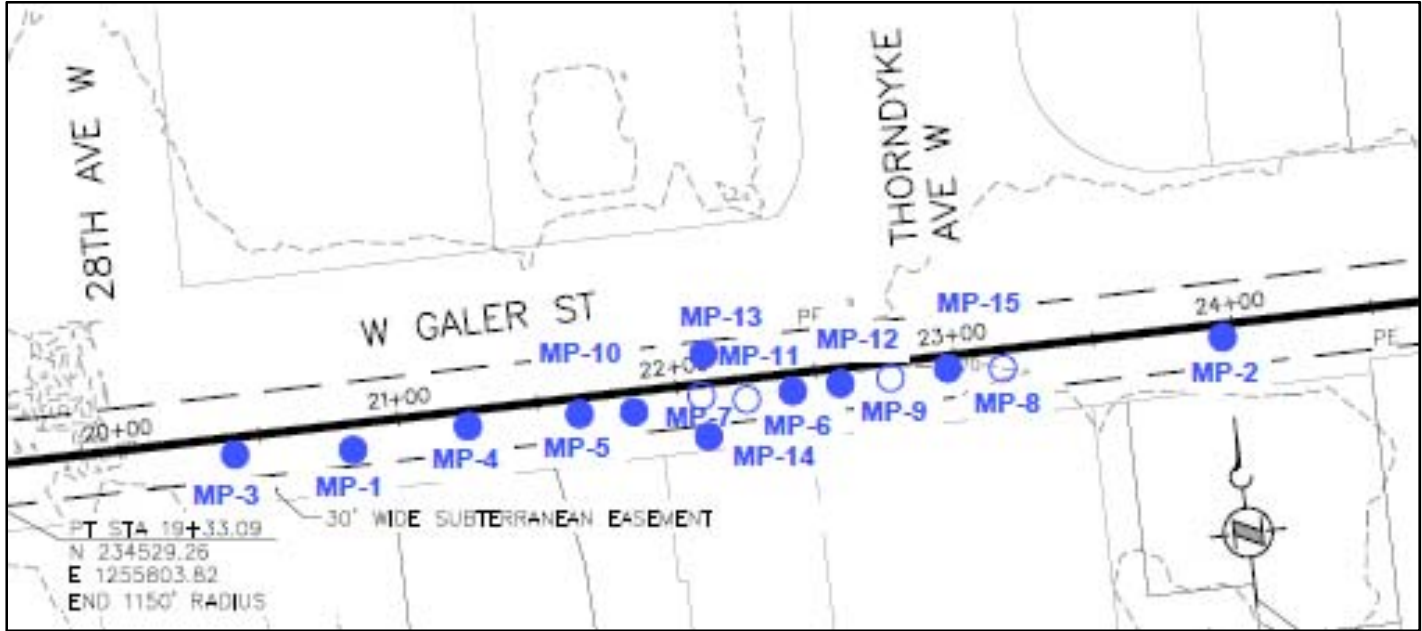
Each dot represents a 6-inch hole drilled by County contractors to search and fill areas of soil loss along the pipe.

Hole (MP = "Magnolia Pipe")	Depth (feet)	Inserted Grout Volume (cubic yards)
MP-1	135	5.0
MP-2	141.5	12.6
MP-3	135	2.1
MP-4	135	2.3
MP-5	135	2.6
MP-6	135	19.9
MP-7	135	98.0
MP-8	140	2.3
MP-9	140	27.0
MP-10	140	4.9
MP-11	140	23.0
MP-12	140	59.0
MP-13	140	198.0
MP-14	181.5	121.4
MP-15	140	3.2
		TOTAL 581.3
