Date: 31 October 2017

Subject: Raging River Quarry Bridge Inspection  
BergerABAM Job No. A18.0095.00

This letter report summarizes our inspection of the bridge at the Raging River Quarry between Preston and Fall City, Washington.

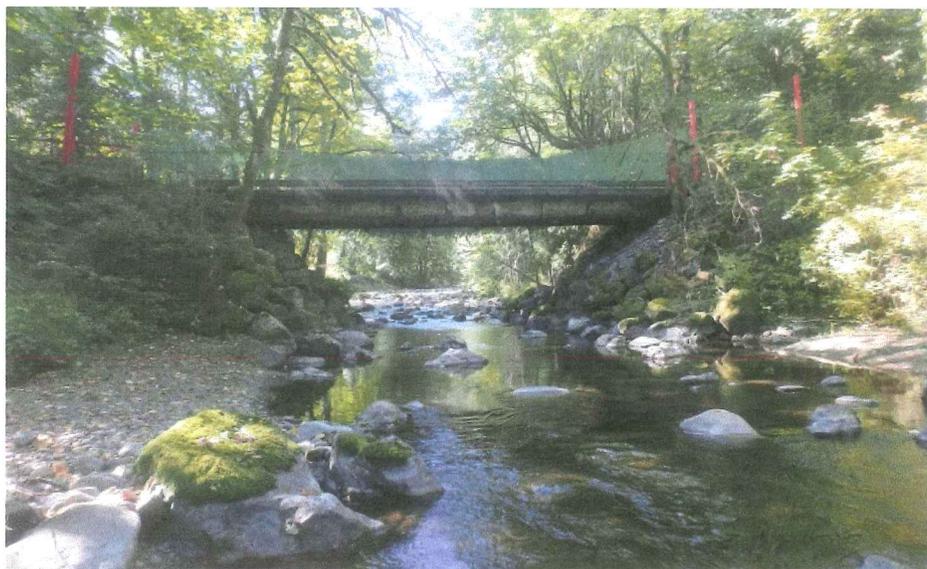
The Raging River Quarry Bridge (Photo 1) is located on the west side of the Preston – Fall City Road and provides access to the quarry site. The bridge is a simple span, two-girder steel bridge with a timber deck. The overall deck length is approximately 63'-4"; overall deck width is approximately 14'-0". The span is approximately 61 feet.

**Photo 1 - Overall view of the bridge looking upstream. Preston-Fall City Road is to the left; the quarry to the right.**

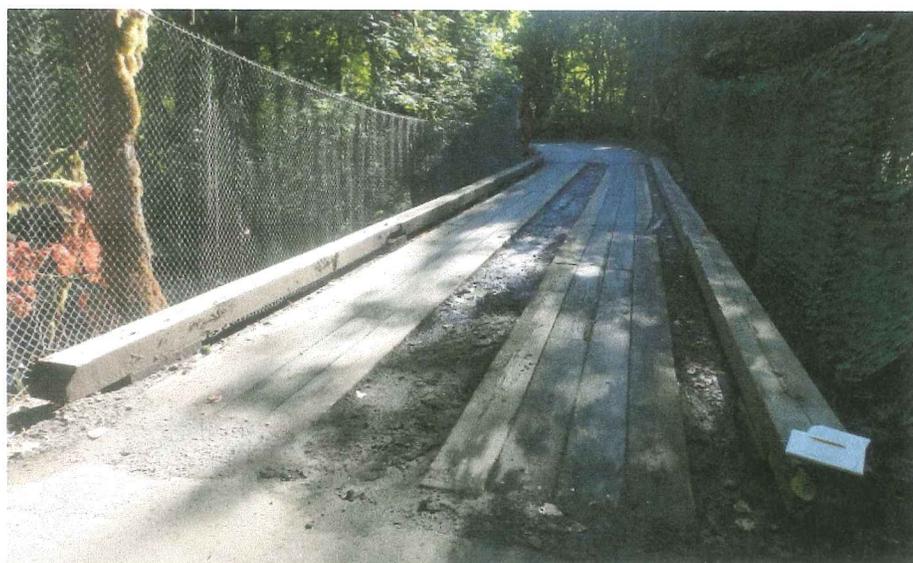
The deck consists of treated 8x12 timbers bearing on the girder flanges perpendicular to the bridge longitudinal axis. The deck timbers do not appear to be fastened to the girders. Tire travel lanes are fabricated from four 3x12s laid side-by-side at each wheel line; see Photo 2. The travel-lane planks are spiked to the timber deck at each plank end. Curbs located at each edge of the deck are fabricated from 8x12 timbers that are fastened to the deck planks with bolts.

**Photo 2 - Overall view of the bridge deck looking to the east toward Preston-Fall City Road.**

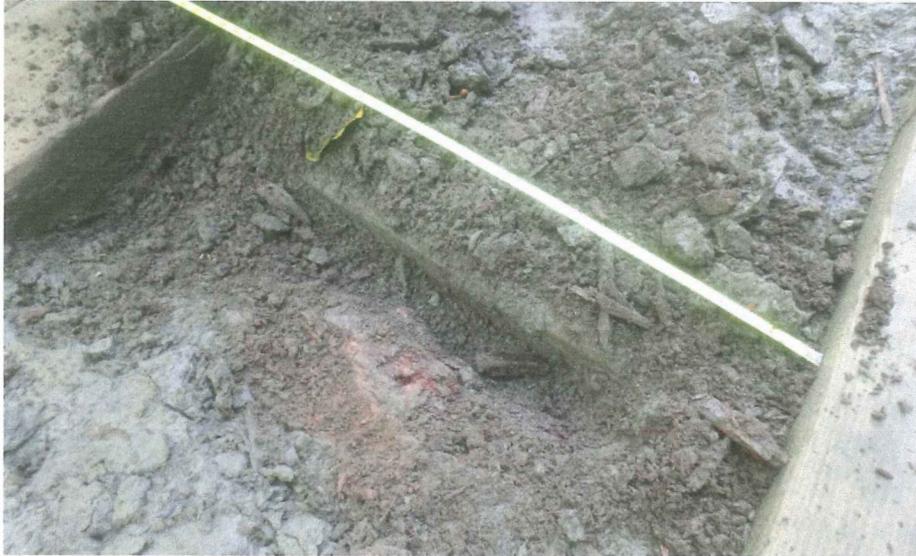
The deck planks, travel-lane planks, and the curb members were sounded with a hammer. The results indicate that the last few inches of four of the travel lane planks, two of the transverse cross members (Photo 3), and one section of curb timber (Photo 4) are experiencing dry rot. The dry rot in the curb section is up to seven inches deep, while in the two transverse deck timbers the dry rot is up to four inches deep.

**Photo 3 - Dry rot damage in transverse timber deck member**

The one curb section and two transverse deck timbers currently observed with dry rot should be replaced during the next routine maintenance, or earlier if their condition worsens. Attachment of the east end of the northern curb timber should also be corrected, and missing washers and nuts below deck should be installed.

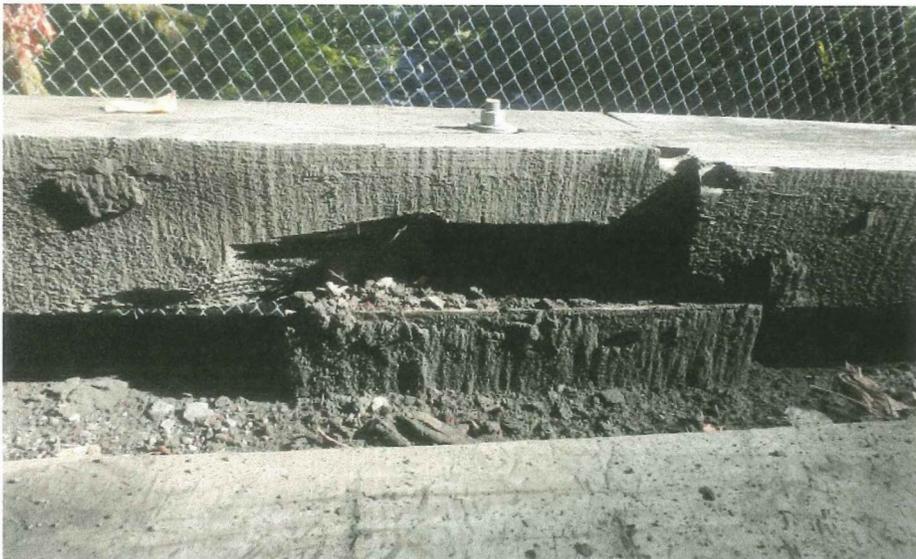
**Photo 4 - Dry rot damage in timber curb member**

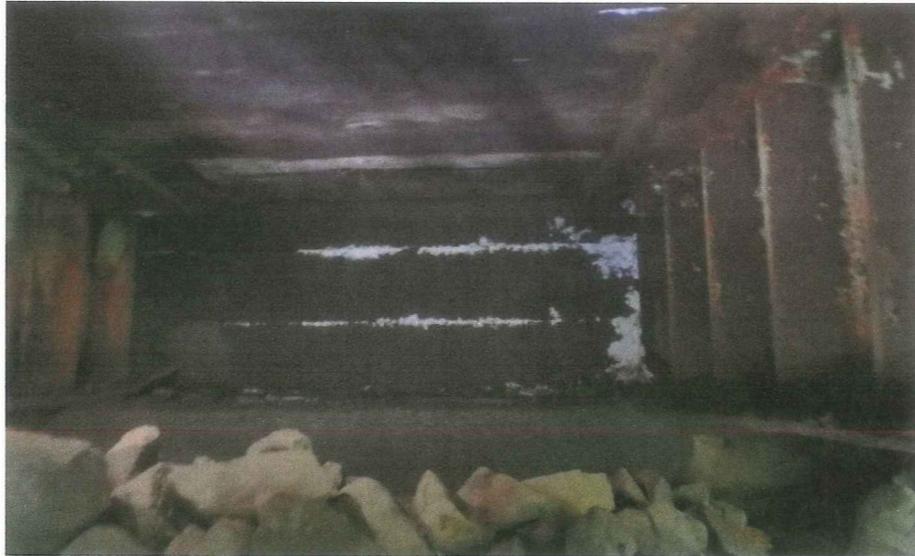
The girders appear to be placed directly on the concrete abutment; no bearings were visible.

The abutments appear to be 12-inch-thick, cast-in-place concrete spread footings (Photo 4). It is unlikely that the abutments are pile-supported because the abutment slab is too thin to provide adequate pile attachment. The abutment back wall is made of 12-inch timbers supported on the footing and bearing against the ends of the girders. Both abutments appear in good condition based on the visible portions.

**Photo 5 – West end of the bridge. Note the web stiffeners welded to the girder, the lack of bearings, the concrete spread footing, and the timber back wall.**

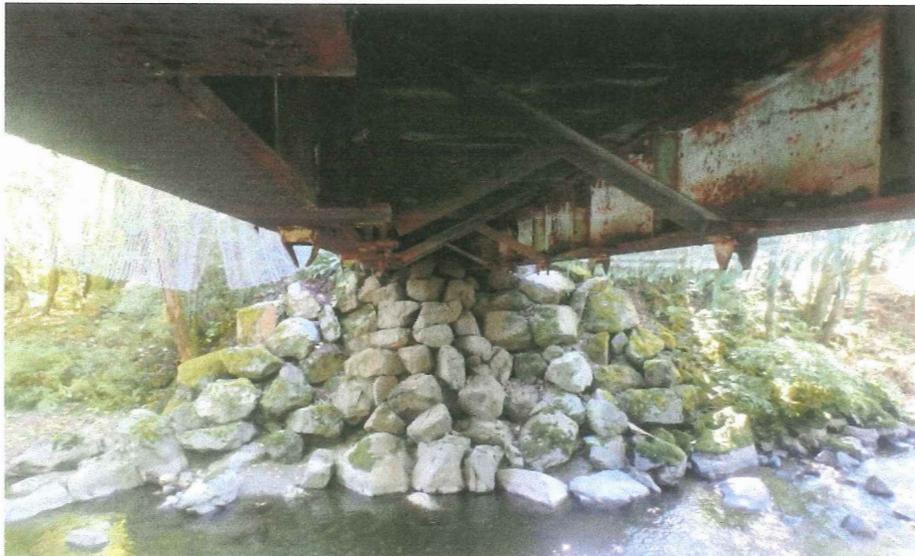
Diaphragms fabricated from various sizes of steel angles have been attached to the girders at four locations (Photo 5).

Armor rock at the east abutment is providing adequate protection (Photos 6, 7 and 8). Armor rock at the west abutment directly beneath the structure was previously noted as displaced during the 2007 inspection, and now appears stable and has been supplemented by the addition of quarry spalls.

**Photo 6 – Diaphragms made from steel angles. Note the cover plate welded to the bottom flange of the girders. Also note the good condition and distribution of the armor rock at the east abutment.**

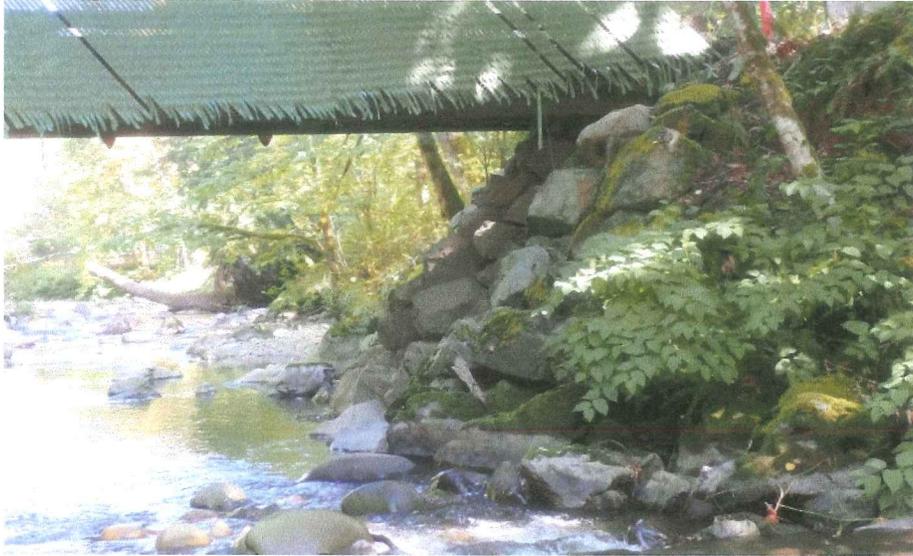
**Photo 4 – Armor rock protection at the upstream side of the east abutment is in good condition.**

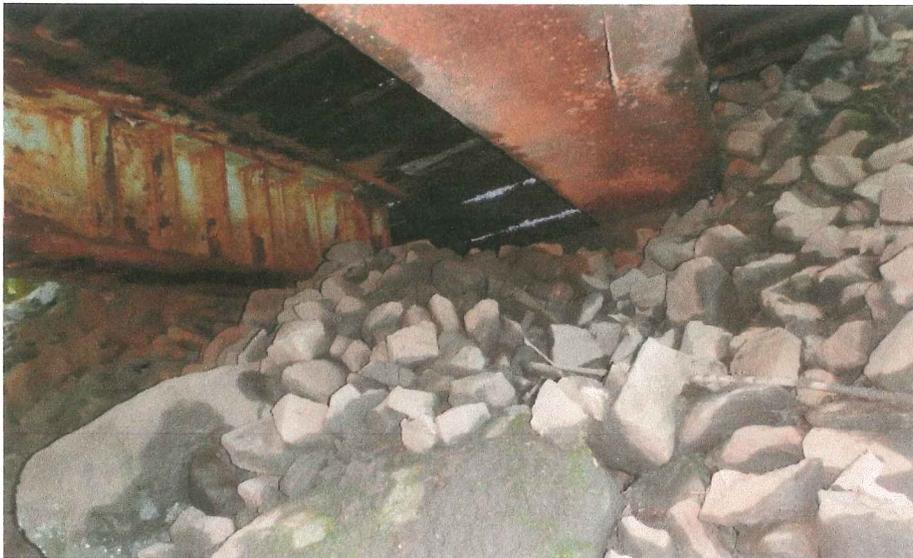
When comparing the 2007 photos to the present conditions, it appears as though some individual pieces of armor rock are in slightly different locations. However, this likely occurred during placement of the quarry spalls as at least one large rock moved up slope rather than down slope, which indicates the repositioning of some armor rock was needed.

**Photo 5 – View of the west abutment. Note the quarry spalls which have been added since the previous inspection.**

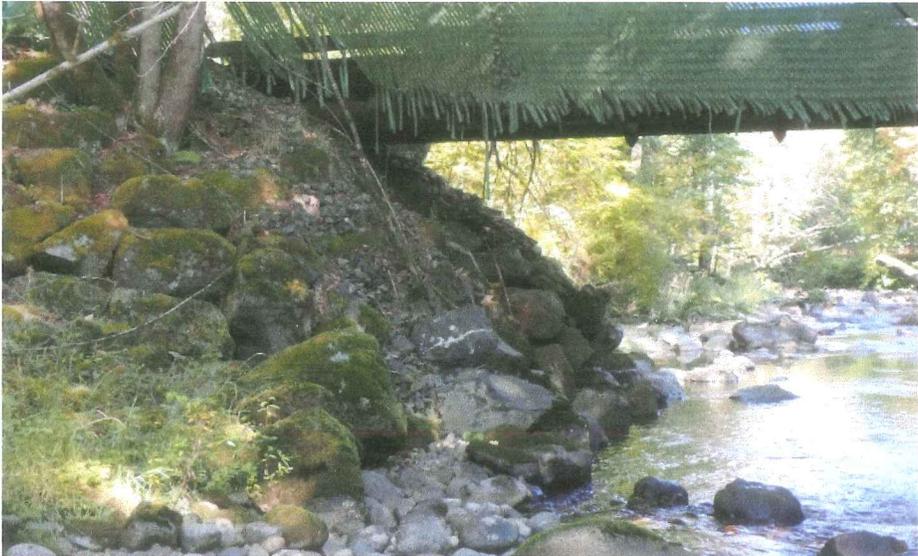
**Photo 6 –View of the armor rock at the upstream side of the west abutment. The riprap is in good condition.**
