August 14, 2017

Eastside Rock Products, Inc.  
32715 Carmichael Road  
Fall City, Washington 98024

Subject: Slope Evaluation Revised Summary Letter  
Raging River Quarry 32715 Carmichael Road  
Fall City, Washington  
File No. 22534-001-01

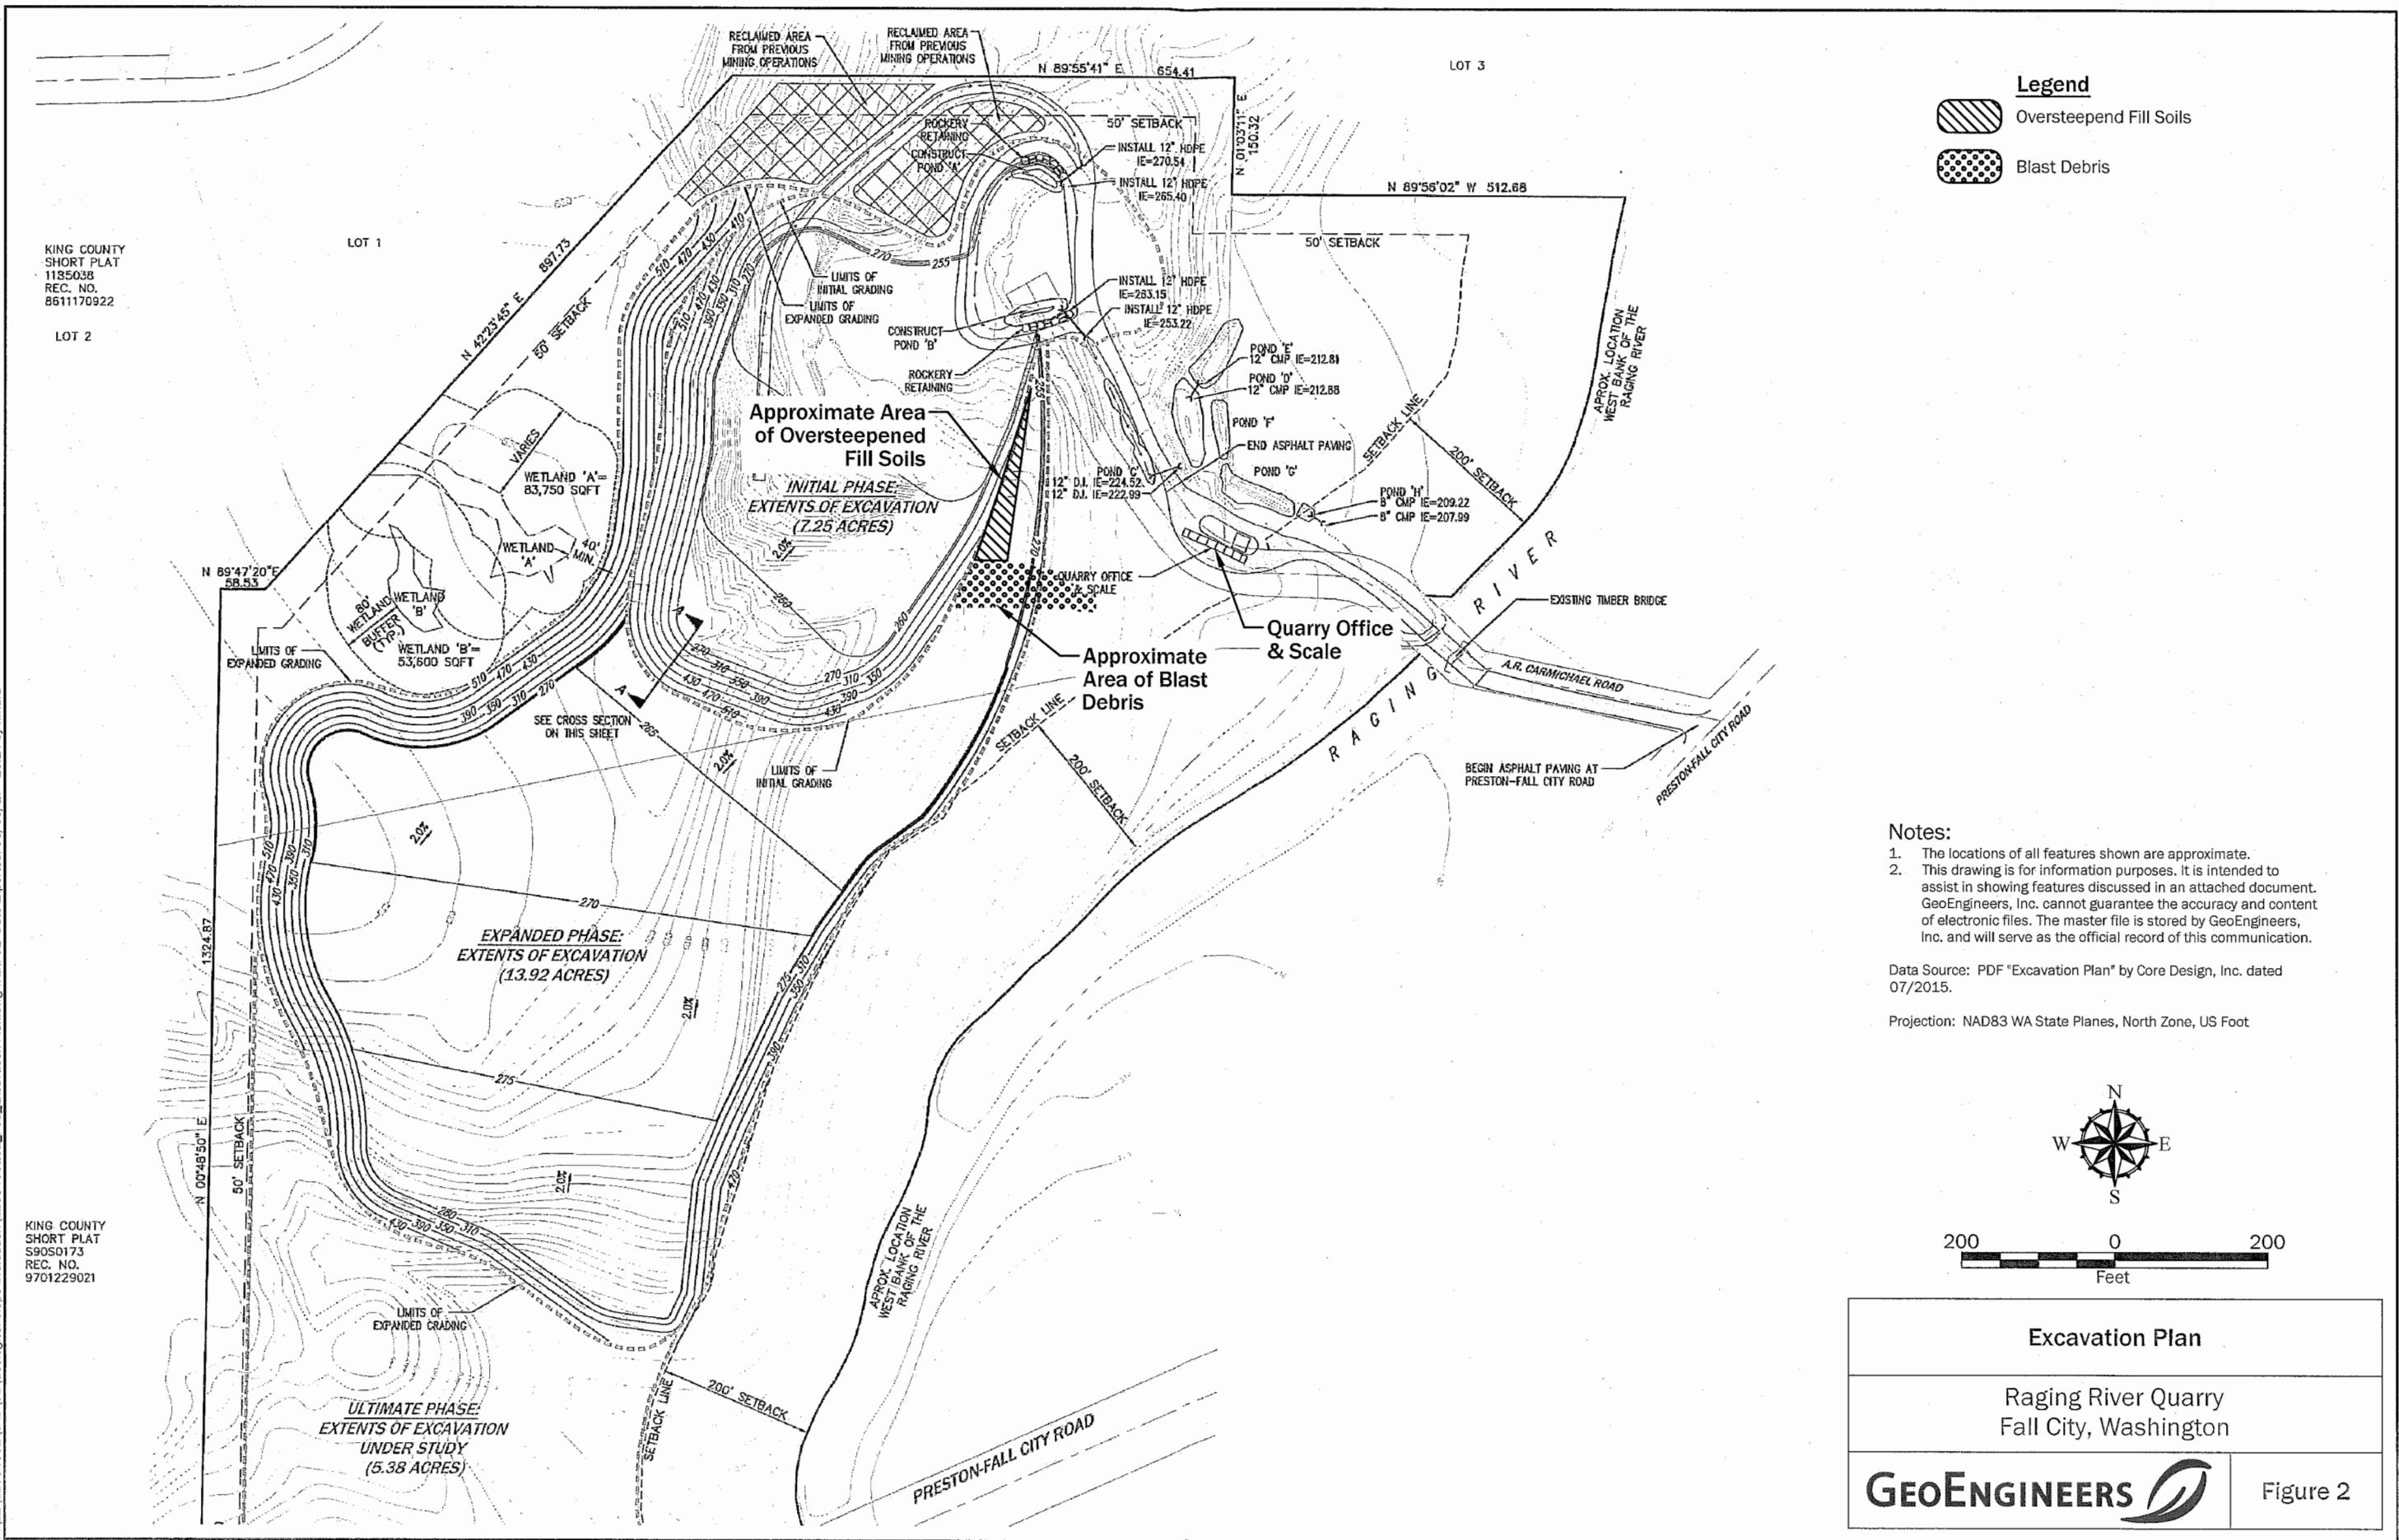
Figure 2. Excavation Plan

We also observed the area impacted by the July 27 shot. We observed blast debris that has apparently mobilized toward the toe of the slope as shown in Figure 2. In general, the debris includes sand, gravel, cobble and boulder sized fragments that are deposited onto the slope that is locally steeper than 70 percent. A number of conifer trees were knocked over by the blast debris. Two large blast debris angular blocks of rock were greater than 6 feet in diameter.

The area upslope of this flagging includes tailings/waste/fill soils in placed by Eastside Rock Products in May 2017 (Figure 2). The tailings consist of loose sand, silt and gravel (glacial gravel deposits) from overburden that appeared to have been locally compacted with an excavator bucket on the face and near the top of the slope. In other places, the fill soils appeared to have been end-dumped and were in a loose, uncompacted condition. The fill gradients exceed 70 percent locally. The thickness of the fill soils upslope of the 300-foot elevation ranges from approximately 5 to greater than 20 feet locally.

We observed a drilled blast hole as close as 10 feet from the break-in-slope to the east where the oversteepened fill soils are located. The exact location of the shots is not clear from the blast report and we observed no other drill holes.

It is our opinion that blasting activities on July 27, 2017 were too close to the face of the slope. It is also our opinion that the oversteepened fill soils are at risk of erosion and potential failure during the upcoming wet season. Prior to the wet season (October 1) we recommend that Eastside:

1. Reduce the slope gradient of the tailings/waste/fill soils upslope of Elevation 300 to a 2 Horizontal :1 Vertical (50 percent) slope. Alternatively, a steeper slope could be designed with a mechanically stabilize earth (MSE) wall that includes a series of compacted lifts built up with a geo-grid or other equivalent material, and a coir fabric facing. This would require laboratory testing of the tailings/waste/fill soils for appropriate engineering design of the MSE wall.

2. During the regrade of the oversteepened fill recommended above, we also recommend removal of loose debris (gravel, cobble and boulder size debris) that can be safely retrieved by an excavator from the area up and downslope of Elevation 300 to reduce the risk of instability.
