# **LANDSLIDE MAPPING FOR DPER: POTENTIAL HAZARDS IN UNINCORPORATED KING COUNTY**

## **Summary and Purpose**

**Gregory R. Wessel, PhD, LG, LEG (greg.wessel@kingcounty.gov)**  
**King County Department of Permitting and Environmental Review**  
**Updated June 22, 2016**

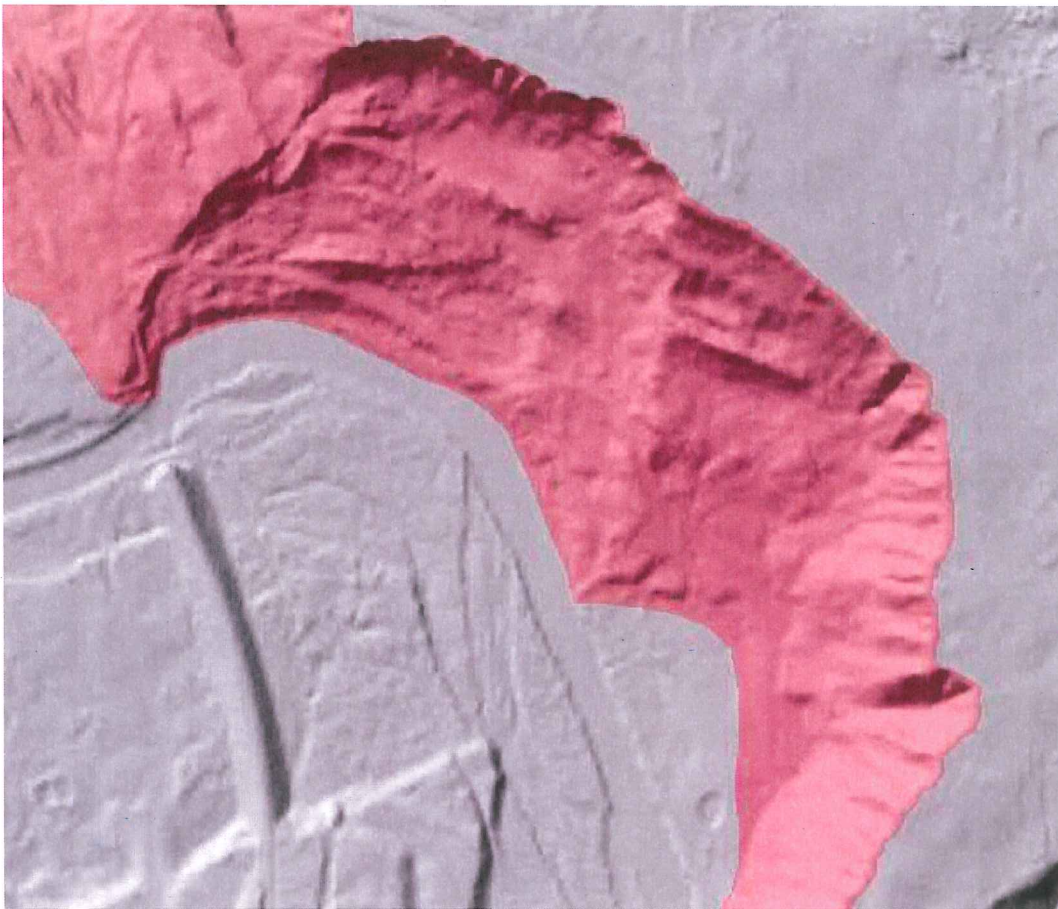
Figure 3. Large slump on the Cedar River at the Dorre Don Reach Natural Area. Field of view is roughly 2500 feet across.

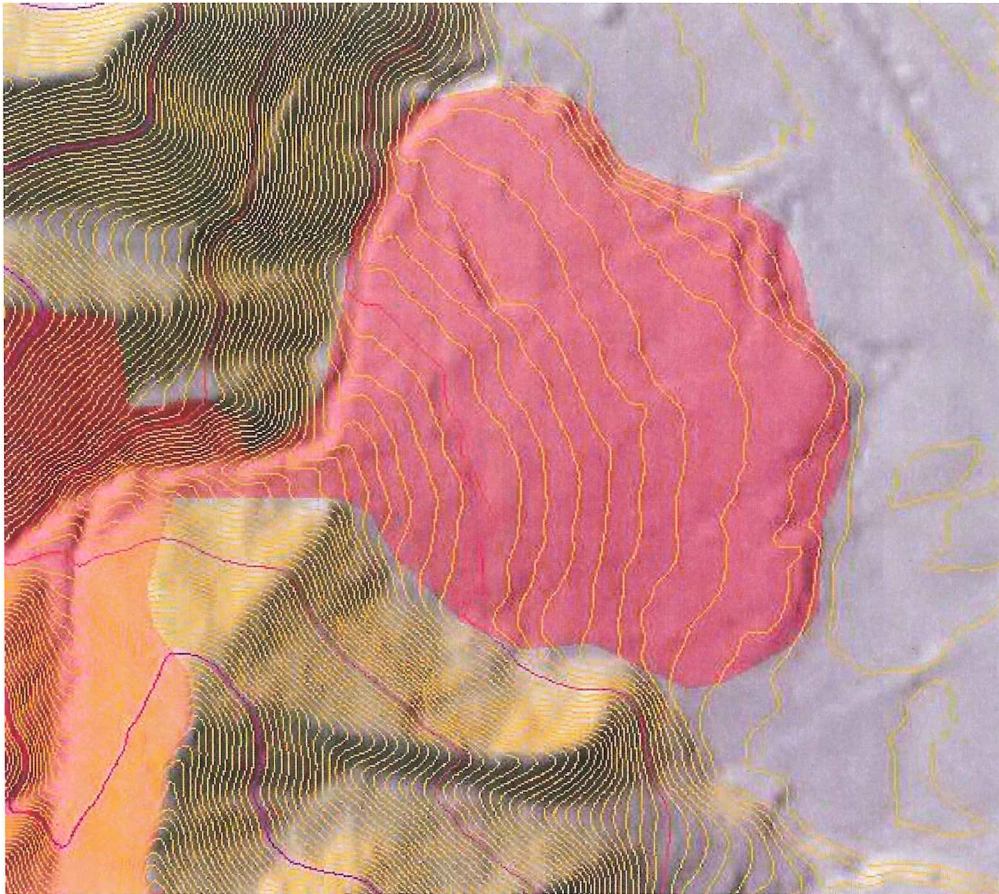
Figure 5. Debris/alluvial fan on the west side of the Cedar River valley near Cedar Grove. Field of view is approximately 1000 feet across.

4. **Debris/alluvial fans:** Debris fans are mapped from the LiDAR-derived hillshade and topographic contours using a five-foot contour interval (Figure 5). DNRP-WLRD differentiated fans based on their potential to host damaging debris flows using a landscape-scale method, but DPER's work makes no such distinction because site-specific evaluations are required as needed during building and land-use permit review. The potential for debris flows to occur outside of mapped fans has not been addressed as yet, but future investigations by others may shed light on that issue.

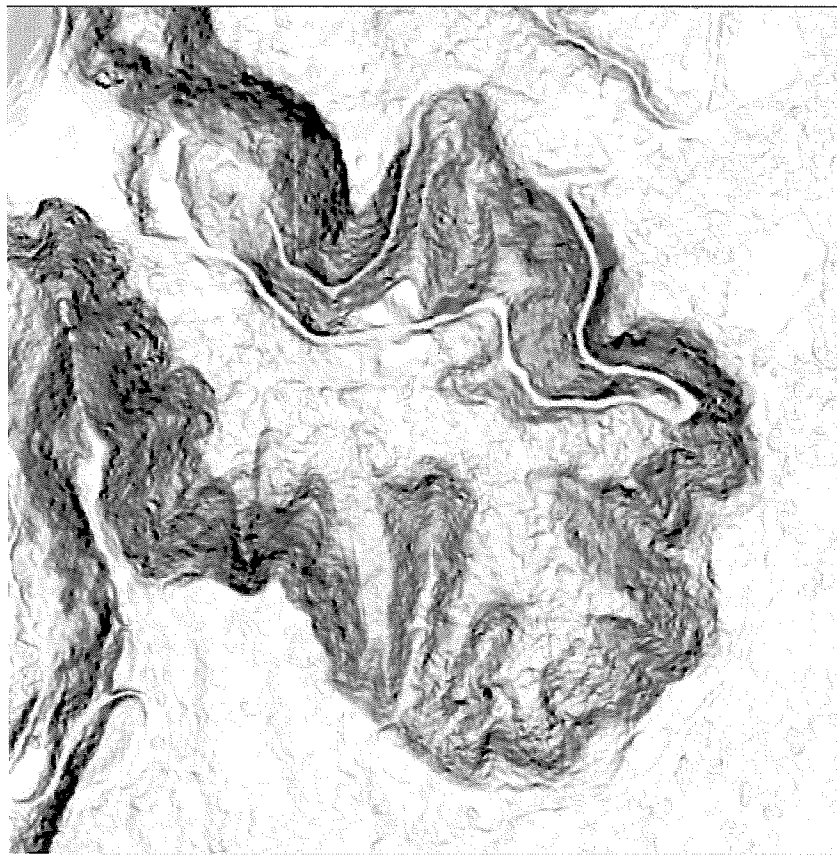
Figure 9. Scalloped basin at Camp Sealth, southwest Vashon Island. Field of view is roughly 2800 feet across.

8. ***Slopes/landforms suggestive of enhanced instability and dominant mass wasting:*** The existing 7.5-minute geologic maps locally document landslide debris associated with some landforms suggestive of increased rates of shallow landsliding, sapping erosion, or rapid soil creep not otherwise visible on the LiDAR imagery. These landforms typically have a “scalloped” appearance; the stream valleys are broad and U-shaped rather than V-shaped as is typical for dendritic drainages (Figures 8 and 9 below). Often the valley floors host numerous seeps, wetlands, and mapped colluvium. Some appear to be quite young features with ongoing rapid erosion/mass wasting, and others appear to have reached a more mature stage where landslide potential is reduced, perhaps reflecting changes in groundwater flow with time. As such, some are mapped as potential landslide hazards and others are not. In any case, all of them are associated with steep slopes, so that any development proposed in those areas will trigger further site-specific study that includes a consideration of mass wasting processes.

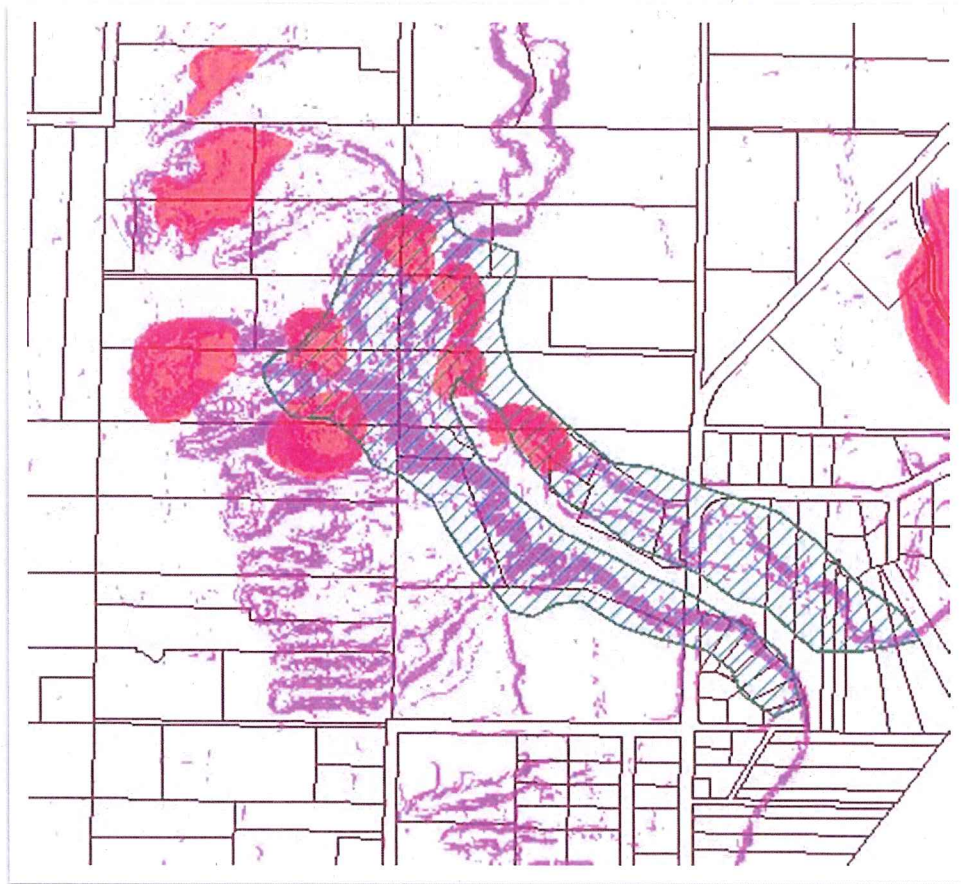
Figure 11. Potential landslide hazards (red) and steep slopes (purple) at the mouth of Judd Creek, Vashon, in comparison to the correlative 1990-vintage SAO landslide hazard (diagonal green lines). Note the differences between the two vintages of map products. Image covers an area roughly 3600 ft. by 4000 ft. Parcel boundaries and county rights-of-way are shown.

The potential landslide hazard and steep slope maps combined appear like Figure 2C above, or Figure 11 below minus the 1990-vintage SAO landslide hazard layer. Individual mapped potential landslide hazards in Figure 11 are shown here in red along with steep slopes (in purple) in sufficient detail to allow parcel-level review and screening. These maps are available as iMap layers on the county's web site, accompanied by explanations of what they mean and how to use
