# TECHNICAL INFORMATION REPORT

## FOR RAGING RIVER ROCK QUARRY

KING COUNTY, WASHINGTON

Project Manager:	Kevin Vanderzanden, PLS
Prepared by:	Stacia Bloom, PE
Date:	December, 2017
Core No.:	10001R

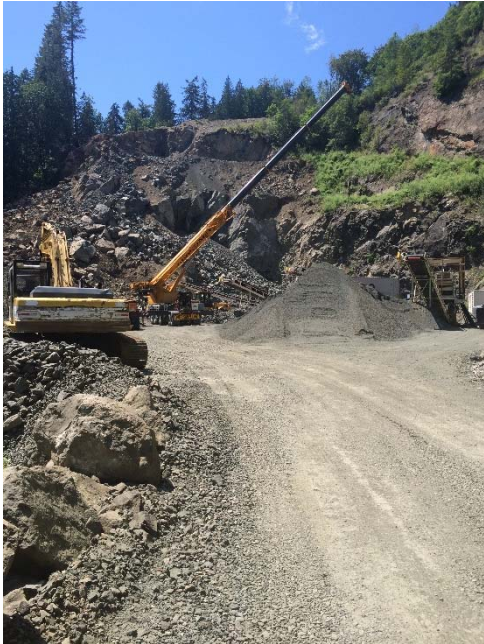
Raging River Rock Quarry: The mining operation, looking at the bowl-like shape.

The site is comprised of varying surface types and boundary conditions. The mine itself is bowl-shaped, situated in the north central region of the project site. There is a service road and vehicular bridge connecting the mining operation to Preston-Fall City Road, over the Raging River. The Raging River creates the easterly border of the site. The central and south central areas are predominately forested regions, yet to be mined. Along the northern boundary, the site contains reclaimed, or reforested, lands from previous mining operations. Nestled along the northwesterly border there are two wetlands that have been identified, flagged, and mapped. There is one identified stream (seasonal, non-fish bearing) on King County's iMap in the southern parcel. The stream course bisects the southern parcel, flowing easterly towards the Raging River. The topography generally slopes from the west to the east, consistent with the overall stormwater conveyance.

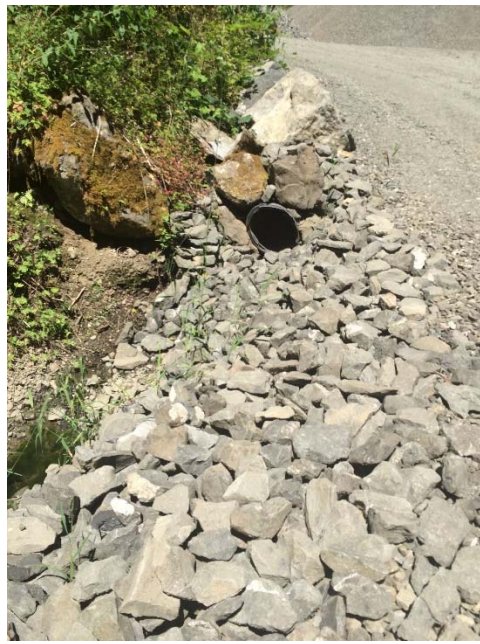
Culvert Conveyance: The mining operation conveying storm waters towards the settling/detention ponds.

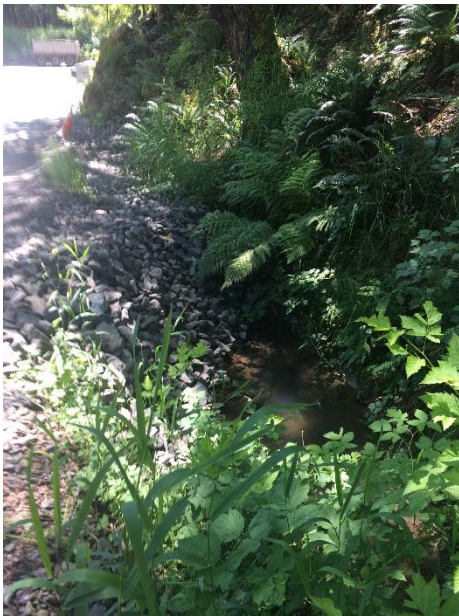
Ponds A-C: Stormwater settling in the first of three ponds that parallel the drive aisle.

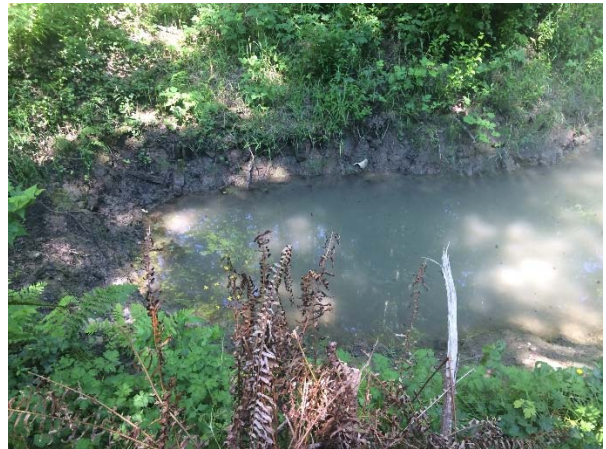
Pond D: Storm water in Pond D.

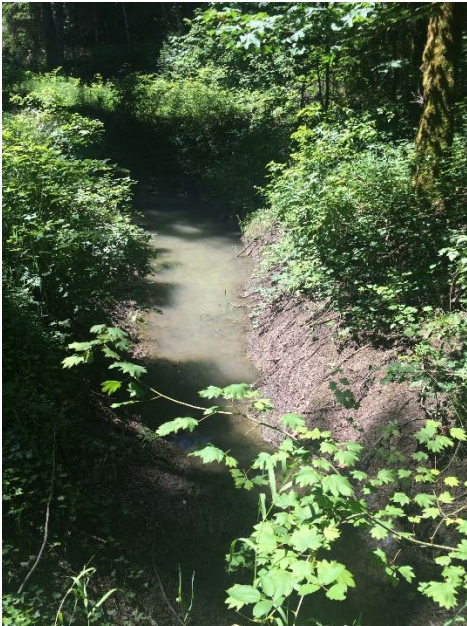
Pond E: Storm water detention Pond E.

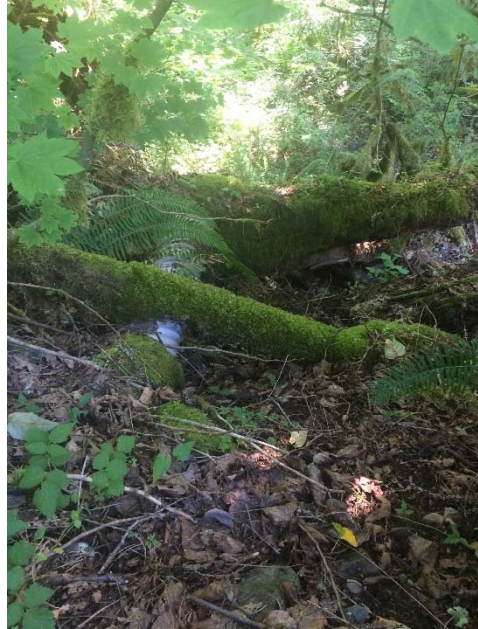
Discharge after Pond H: Culvert discharge after the series of settling/detention ponds, directed towards the 200-foot river setback.

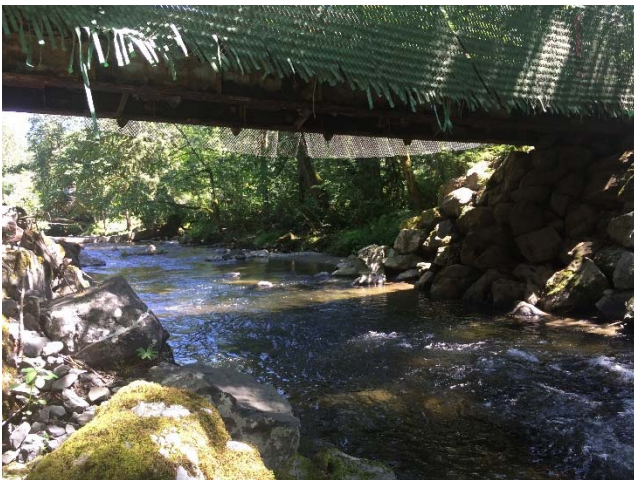
Raging River: A view looking north under the vehicle bridge along the Raging River, stabilized bank.

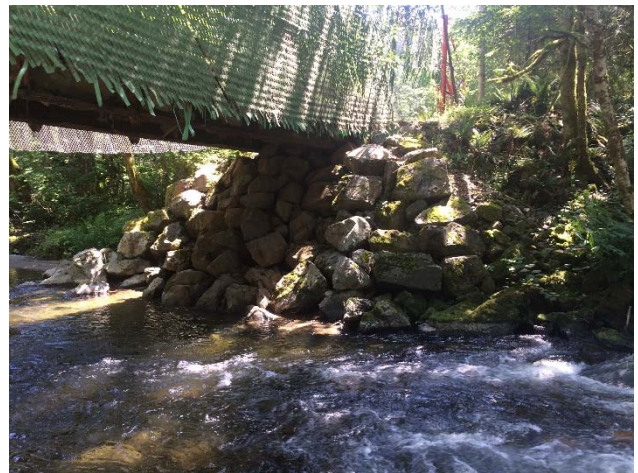
Raging River: A view looking south under the vehicle bridge along the Raging River, stabilized bank.

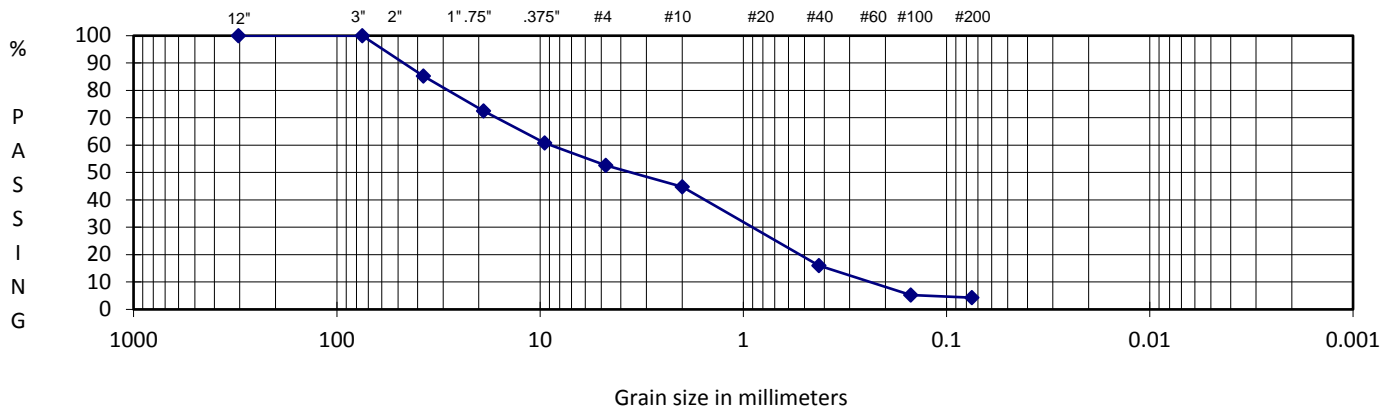
DESCRIPTION	Gravelly SAND with trace silt
USCS	SP

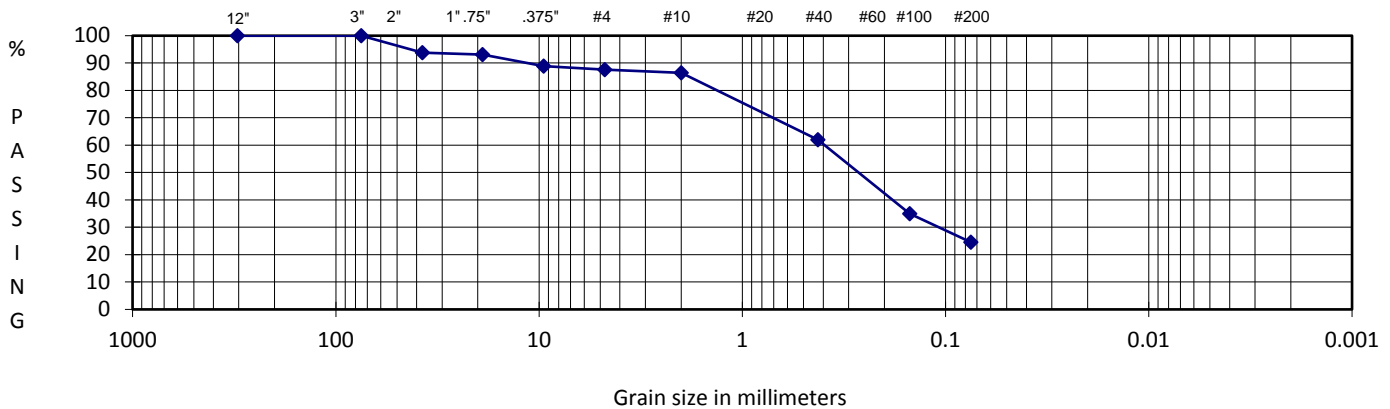
DESCRIPTION	Silty SAND with trace gravel
USCS	SM

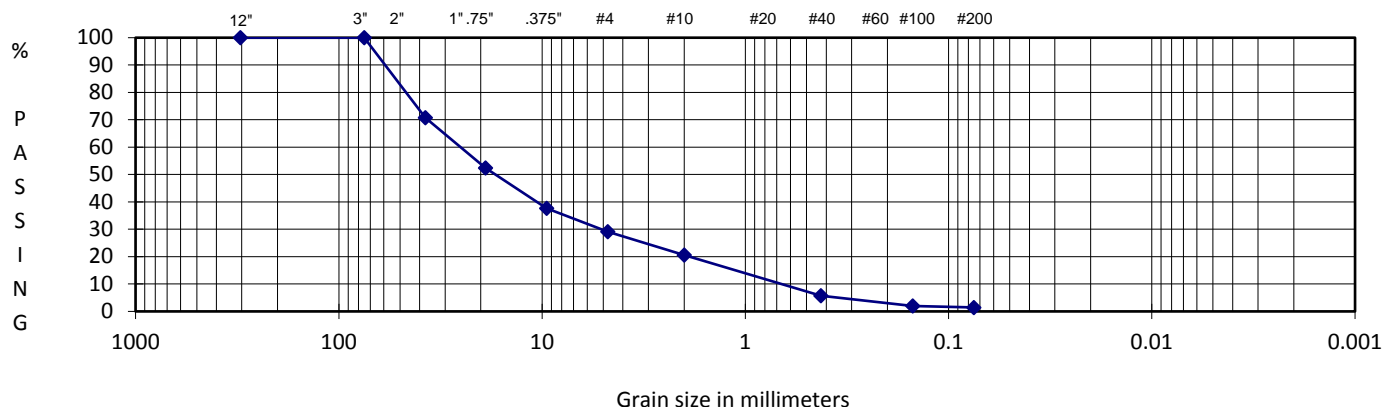
DESCRIPTION: Well-graded GRAVEL with some sand and trace silt

USCS: GW

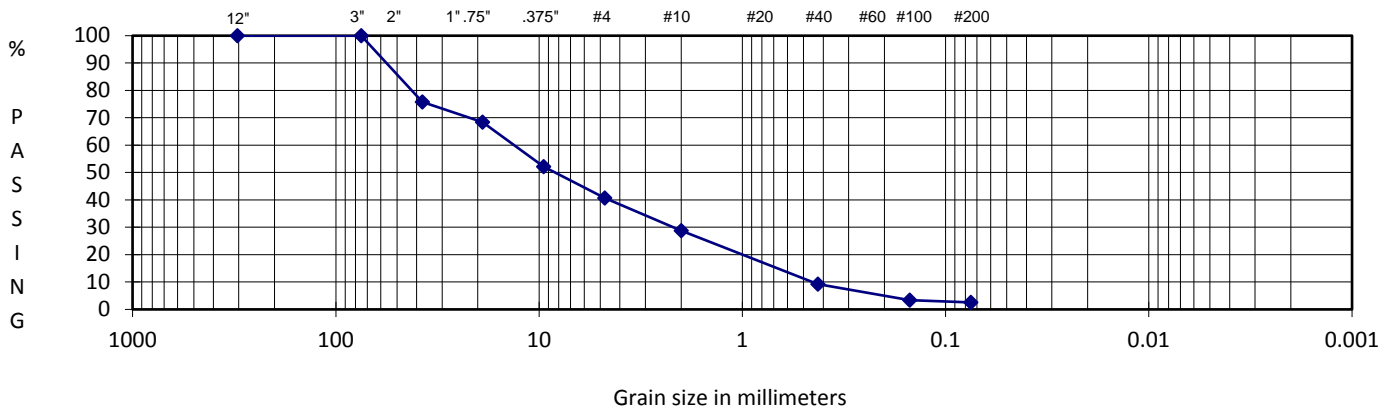
DESCRIPTION	Sandy GRAVEL with trace silt
USCS	GP
