December 1, 2017

Re: **Technical Response for the Raging River Quarry Expansion (Parcel # 222407-9033): Clearing & Grading Permit Application # GRDE15-0166 King County, WA.**

4/28/17 Raging River Quarry Expansion Area Photographs: Near Transect Point T-1-2

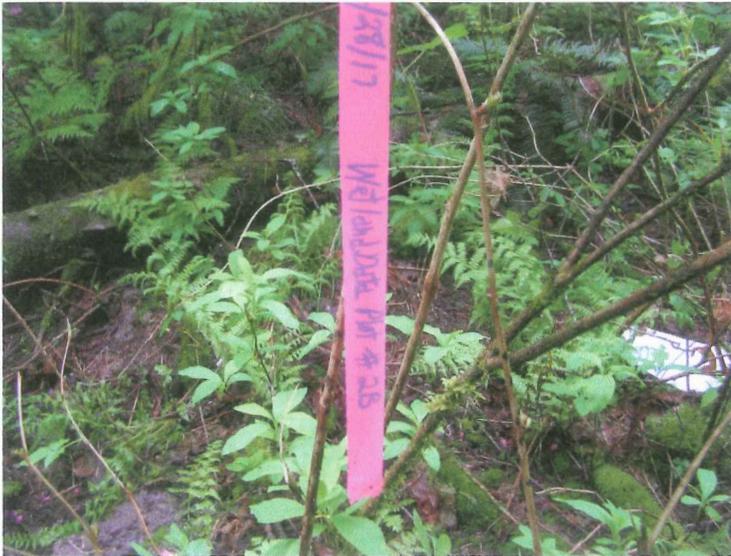
Wetland Data Plot 2B was located within an old excavated exploration pit.

*Acknowledge that there was a ponded area adjacent to the Data Plot 2 location. This small area of 100 to 200 square feet in size is an old excavated pit from previous quarry research related to bedrock depth and the mine. Vegetation was not observed growing in the inundated pit. An attempt to excavate a soil pit in about 4 inches of standing water during the 4/28/17 investigation found the soil profile to be similar as the adjacent soil pits for Data Plot 2. This data plot point is numbered 2B.*

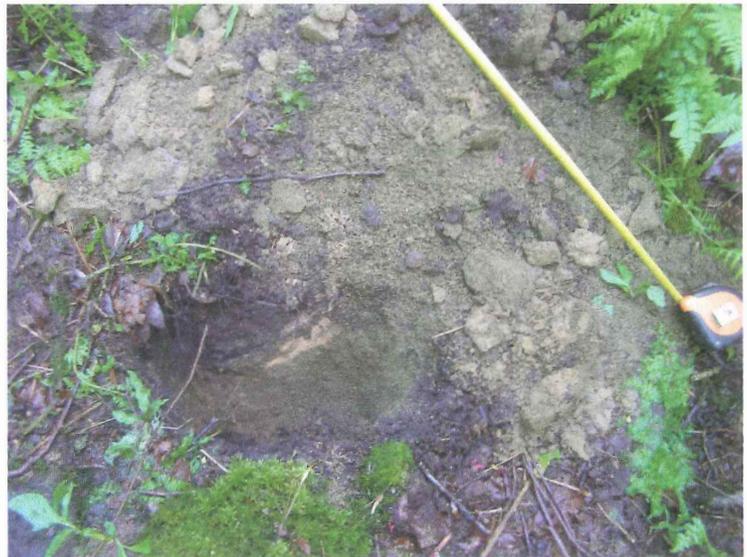
Wetland Data Plot 2A was excavated in an undisturbed area adjacent to Data Plot 2B as a reference soil profile.

*Response: The Data Plot 2 location along Transect T-1 was re-investigated on 4/28/17. A second wetland data plot (#2A) was installed and flagged near the Data Plot 2 that was installed during the 2016 investigation. All wetland data plots (2016 & 2017) from this location are attached to this letter. The vegetation cover is nearly the same and dominated by hydrophytic species – salmonberry and lady fern. However, both soil pits exhibited non-hydric soil due to lighter soil color above a depth of 12 inches (10YR2/2) and below 12 inches (10YR5/3). The soil data as recorded does not meet the criteria of having a "depleted matrix" typical of a hydric soil.*

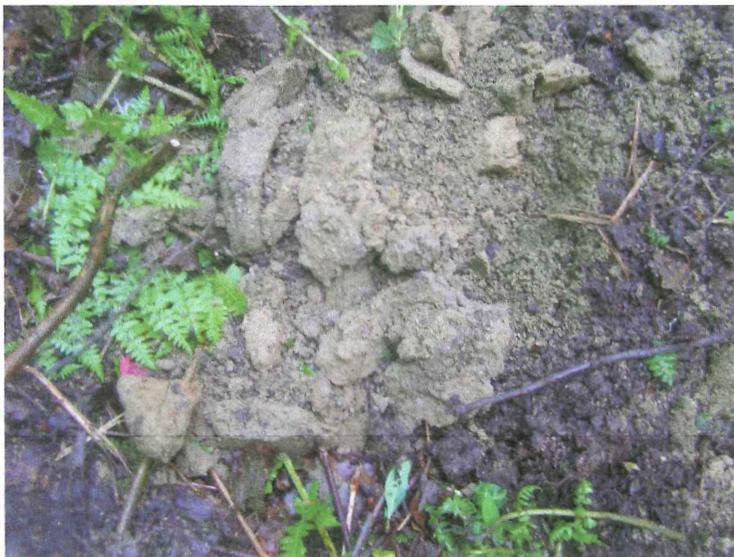
Reference Data Plot 2A has chroma / value 10YR 5/3 sandy loam below 8 inches deep. The bright color is not indicative of depleted soil associated with wetland (hydric) soils. No wetland hydrology indicators are present.

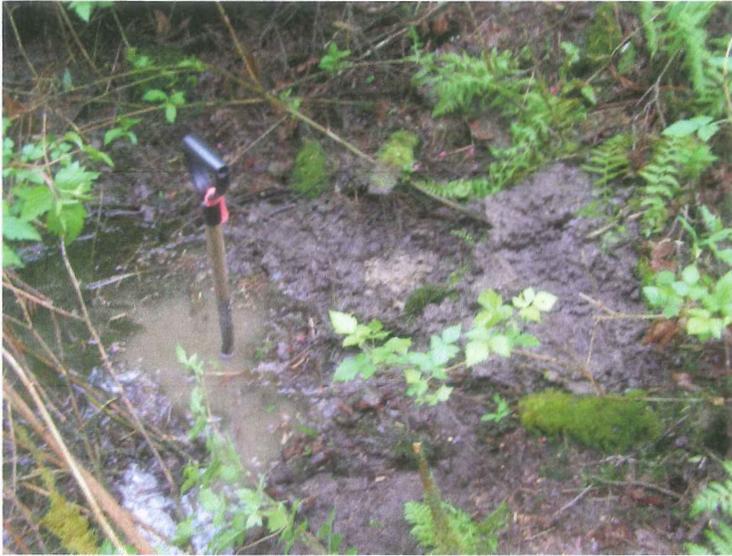
Wetland Data Plot 2B was excavated within the depression in approximately 4 inches of standing water. Salmonberry shrubs and lady fern growing around the outer edges of the depression. The depression intercepts shallow groundwater and surface water runoff.

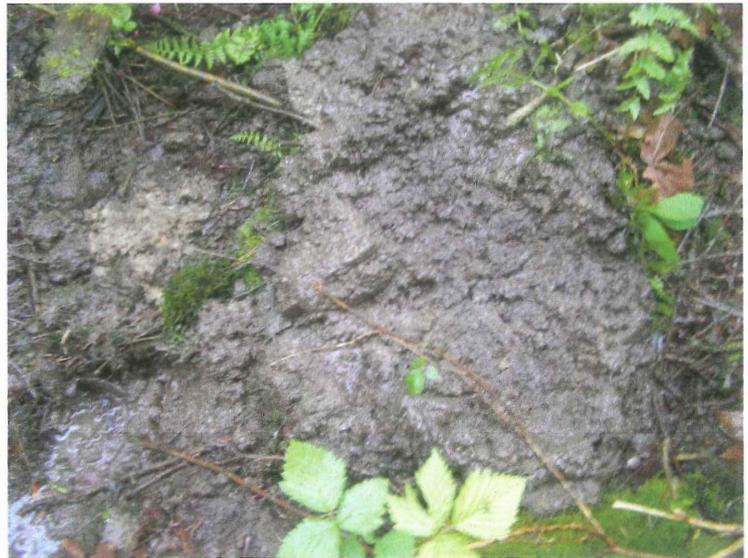
Wetland Data Plot 2B had a soil profile similar to reference Plot 2A but was disturbed years ago. The 10YR 5/3 chroma / value is present at a depth of 18 inches. The data plots all have a dark brown (10YR2/2) color in the upper layer and the lighter brown 10YR5/3 color at depths to 18 inches. The observed soils are not depleted.

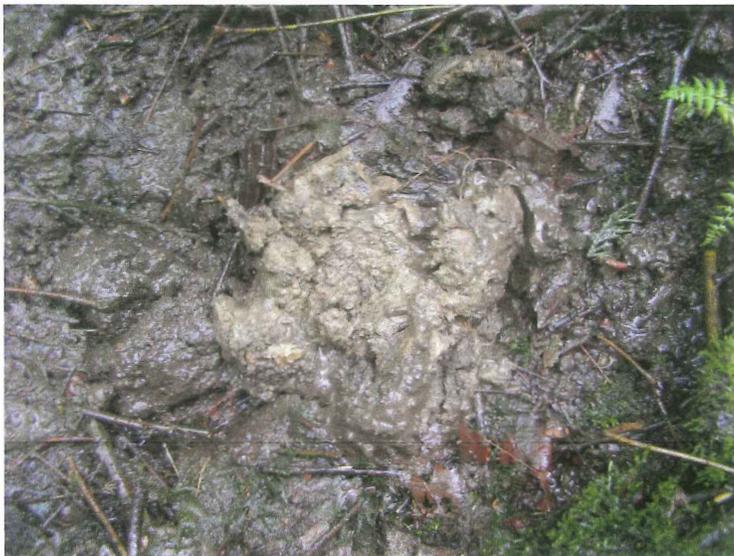
Wetland Data Plot 2B has the same chroma / value color of 10YR 5/3 as observed in the undisturbed area of Wetland Data Plot 2A.
