Revised Report
Geotechnical Engineering Services
Ravensdale Reclamation Trench Filling and
Restoration Project
Ravensdale LLC Property
Section 1, T21N, R6E and Section 36, T22N, R6E
Ravensdale Area, King County, Washington

July 28, 2020
ICE File No. 1352-001

**Prepared For:
Ravensdale LLC**

**Prepared By:
Icicle Creek Engineers, Inc.**

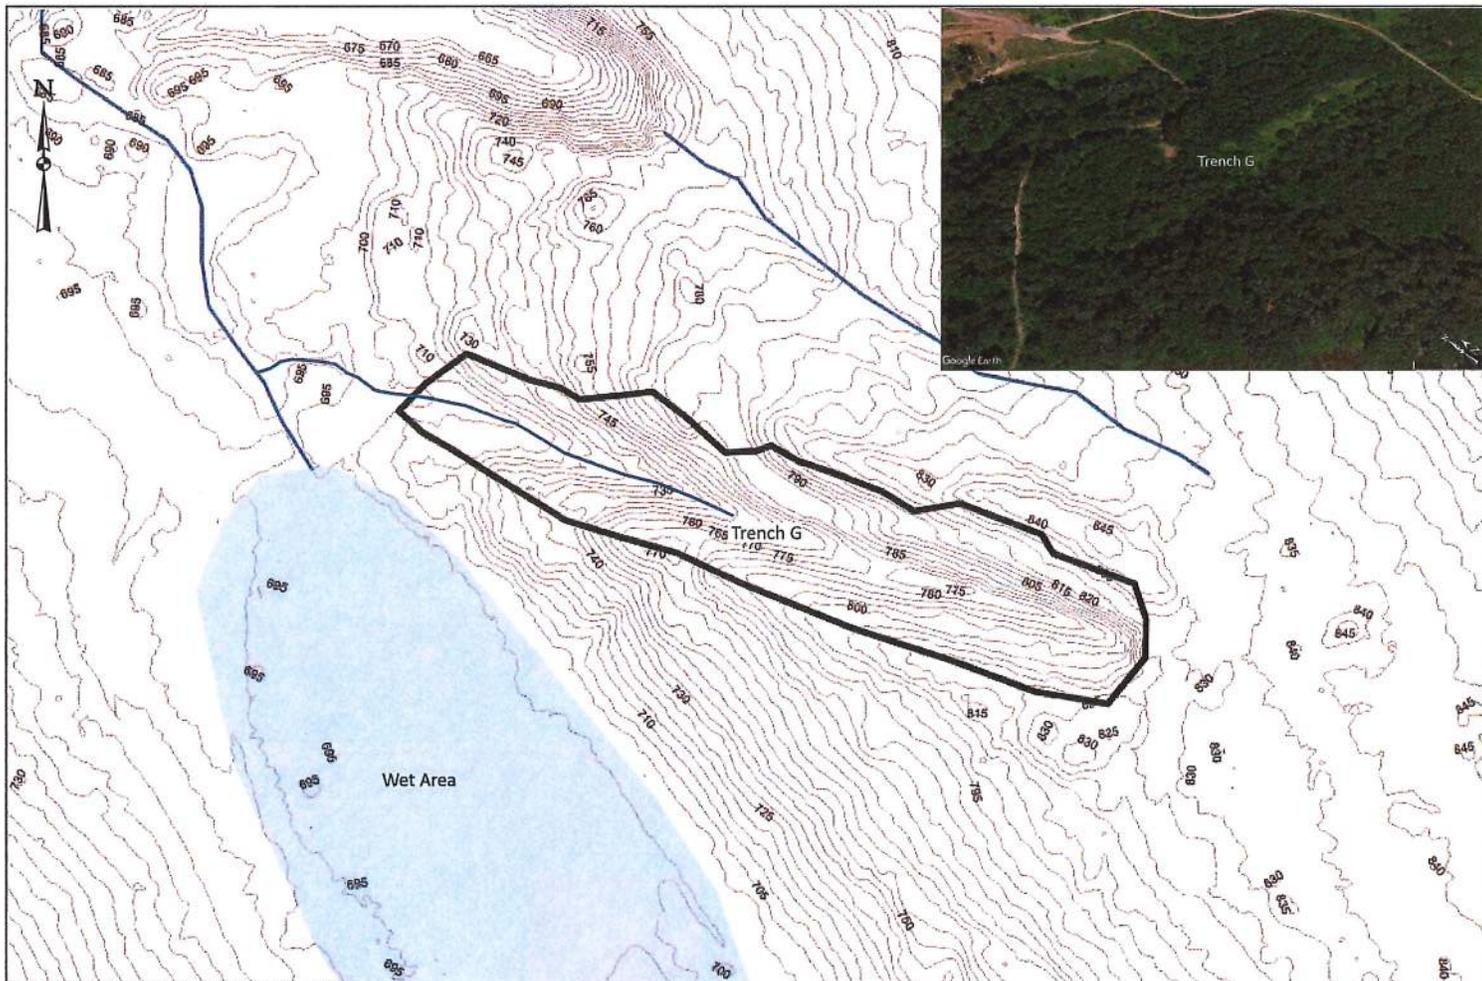
SCALE: As Shown	ICE FILE NO.
DRAWN: RBH	1352-001
CHECKED: KSK	Figure
DATE: 07/26/20	7

Trench G – Trench G as shown on Figure 7 is densely vegetated with brush and trees with a defined stream channel with surface water.

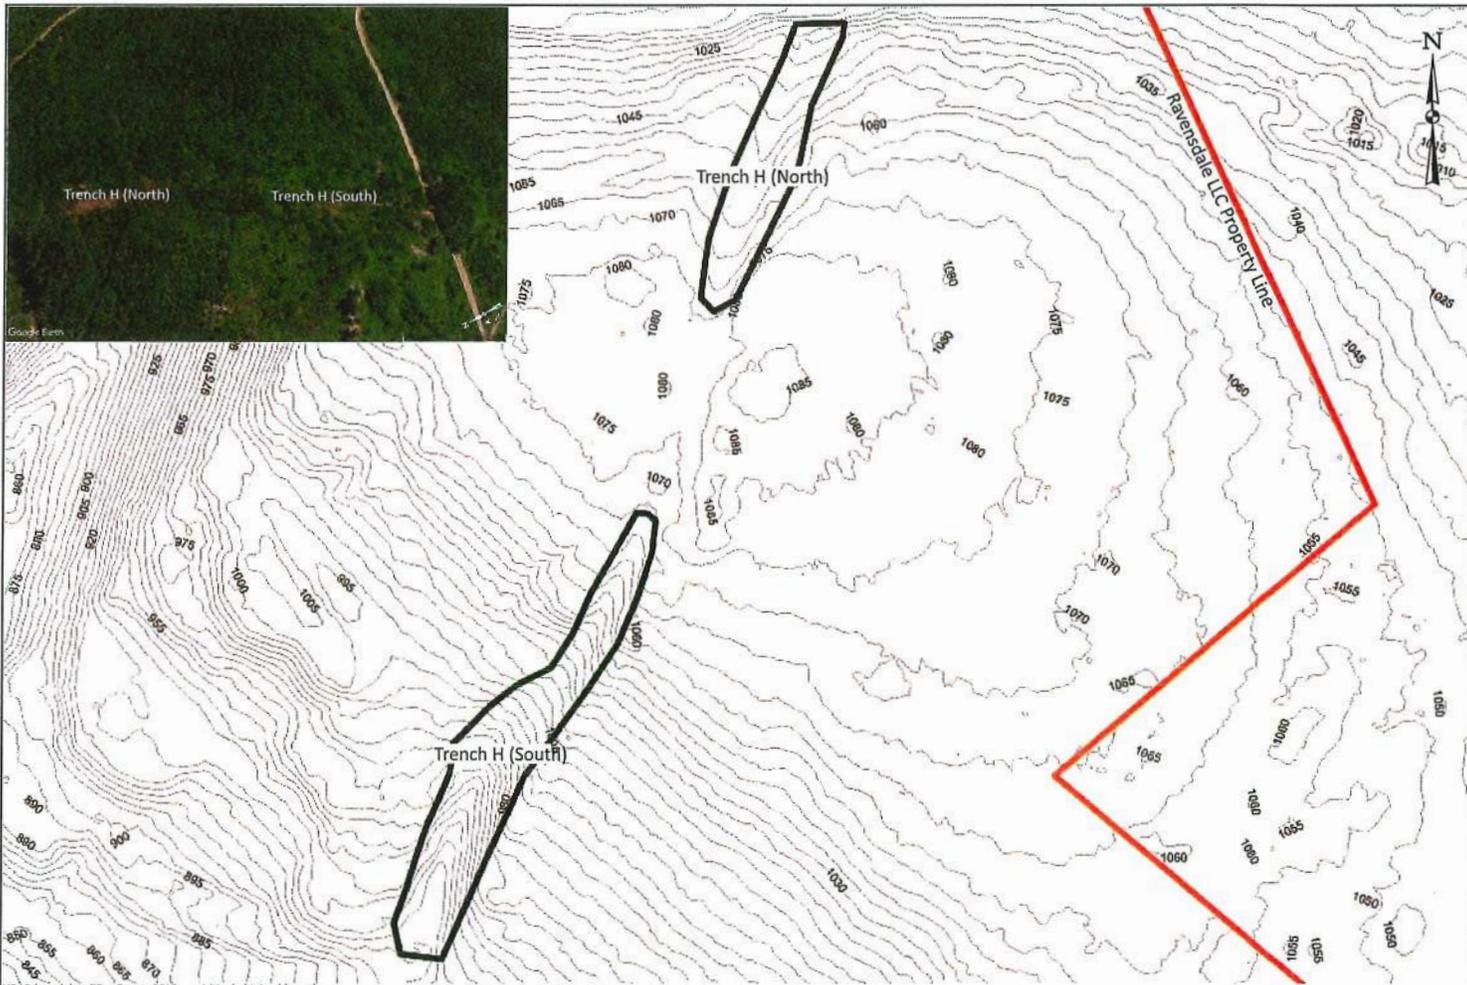
SCALE: As Shown	ICE FILE NO.
DESIGNER: --	1352-001
DRAWING: 888	Figure
CHECKED: KSK	8
DATE: 07/28/20

Trench H (North) – Trench H (North) as shown on Figure 8 is a shallow excavation and is open to densely vegetated. It does not appear that a formal deep excavation ever occurred.

Trench H (South) – Trench H (South) as shown on Figure 8 is a long and relatively narrow partially vegetated excavation that is cut into a moderately sloping hillside.

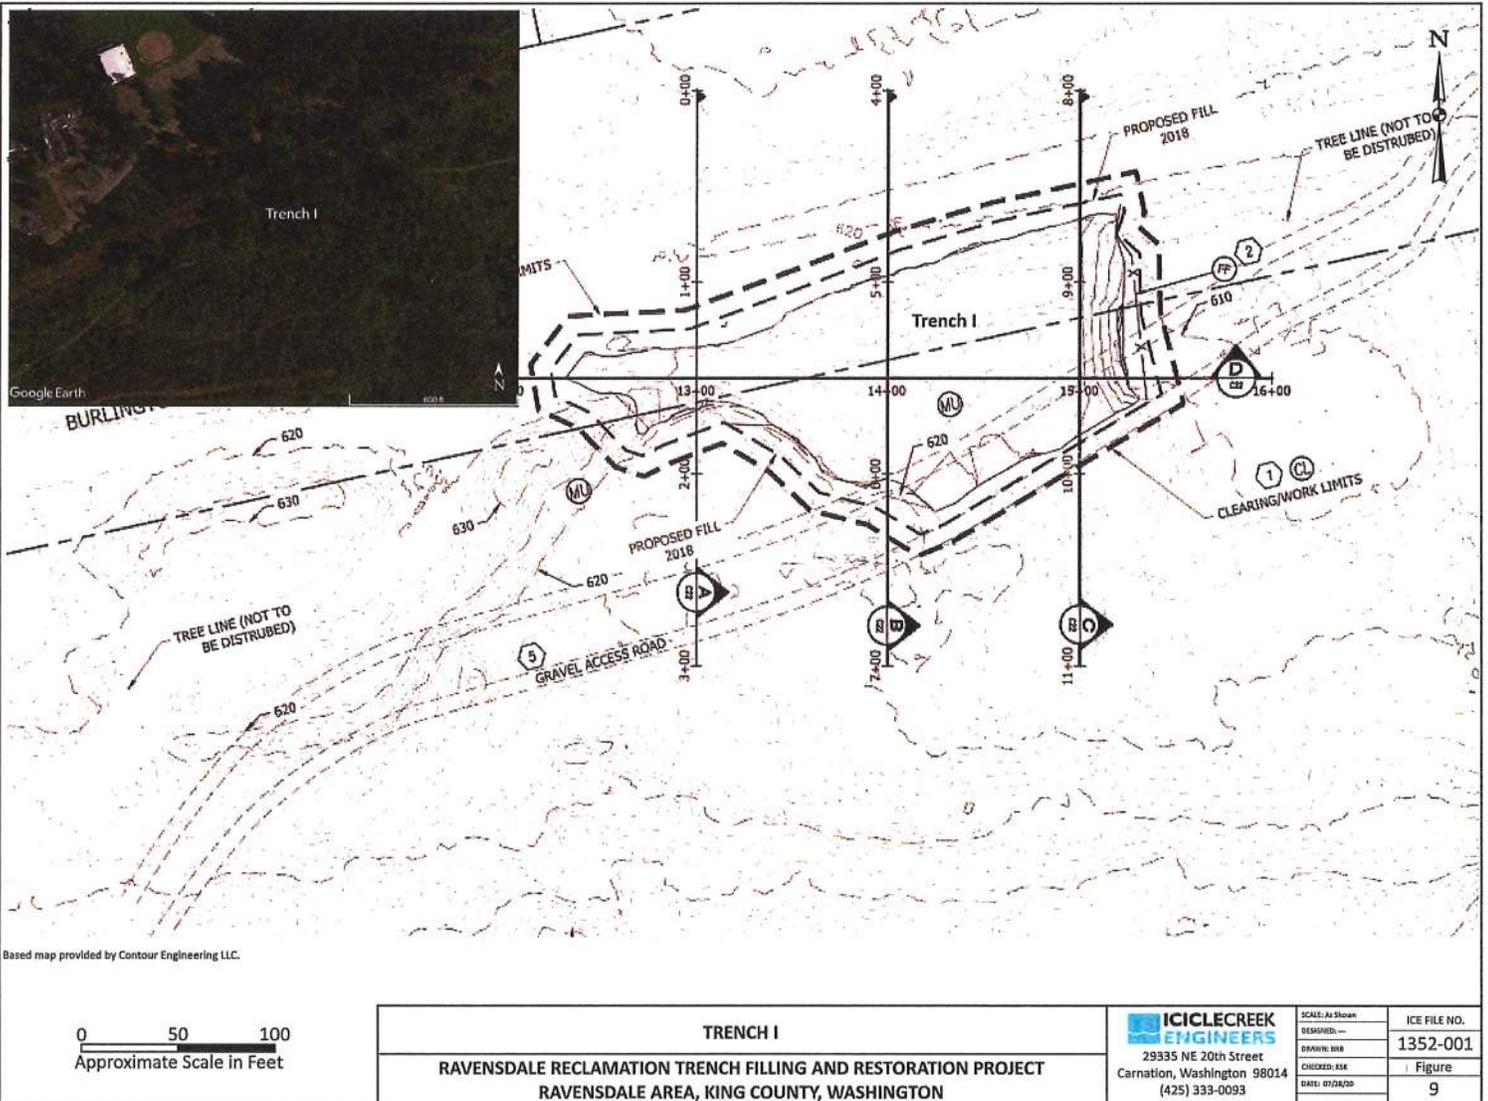
TRENCH I		 29335 NE 20th Street Carnation, Washington 98014 (425) 333-0093	SCALE: As Shown DESIGNED: --- DRAWN: BSB CHECKED: ASK DATE: 07/02/20	ICE FILE NO. 1352-001 Figure 9
RAVENSDALE RECLAMATION TRENCH FILLING AND RESTORATION PROJECT RAVENSDALE AREA, KING COUNTY, WASHINGTON

Trench I – We did not field review Trench I (shown on Figure 9). Based on aerial photographs and LiDAR-based topography, Trench I occupies a nearly-level shallow (less than 5-feet deep) area covered with mature trees and brush. We do not expect that geotechnical issues are of concern for Trench I.
