SILT FENCE DETAIL
NOT TO SCALE

LKSD0000-0002

SHEET NUMBER **C2 2**

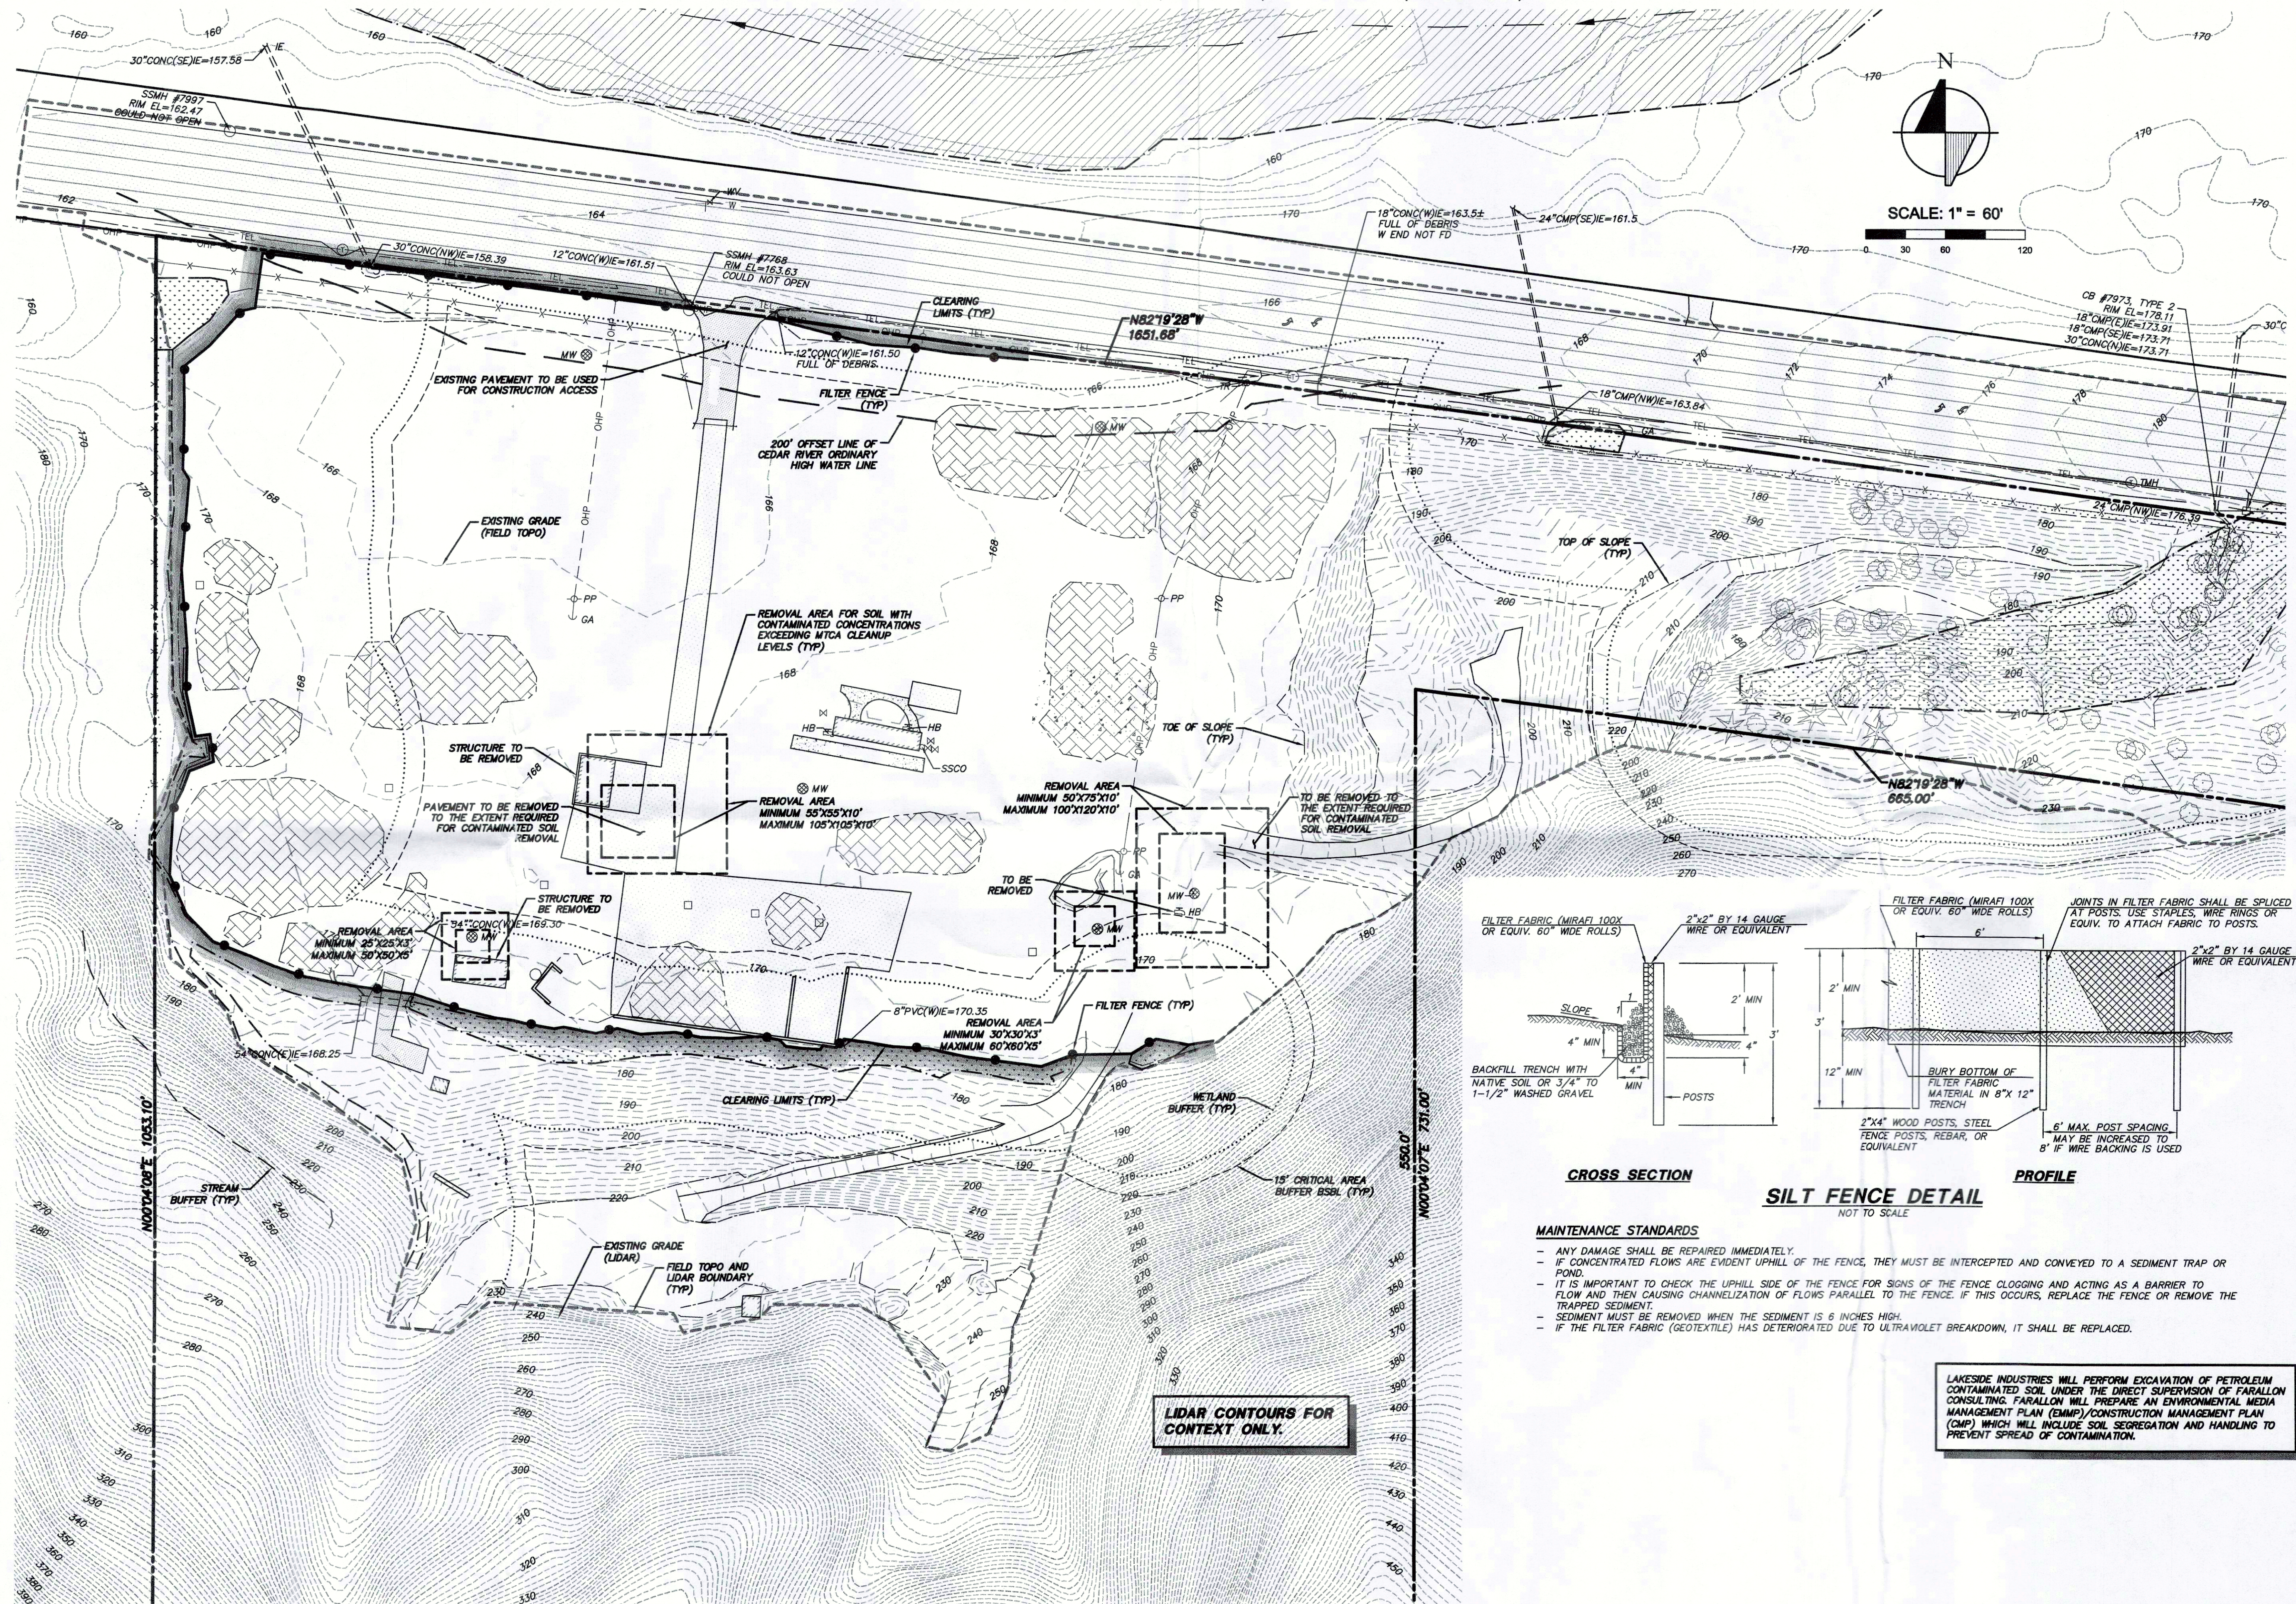
CROSS SECTION

PROFILE

MAINTENANCE STANDARDS

- ANY DAMAGE SHALL BE REPAIRED IMMEDIATELY.
- IF CONCENTRATED FLOWS ARE EVIDENT UPWIND OF THE FENCE, THEY MUST BE INTERCEPTED AND CONVEYED TO A SEDIMENT TRAP OR
- IT IS IMPORTANT TO CHECK THE UPWIND SIDE OF THE FENCE FOR SIGNS OF THE FENCE CLOGGING AND ACTING AS A BARRIER TO FLOW AND THEN CAUSING CHANNELIZATION OF FLOWS PARALLEL TO THE FENCE. IF THIS OCCURS, REPLACE THE FENCE OR REMOVE THE TRAPPED SEDIMENT.
- SEDIMENT MUST BE REMOVED WHEN THE SEDIMENT IS 6 INCHES HIGH.
- IF THE FILTER FABRIC (GEOTEXTILE) HAS DEGRADED DUE TO ULTRAVIOLET BREAKDOWN, IT SHALL BE REPLACED.

LAKESIDE INDUSTRIES WILL PERFORM EXCAVATION OF PETROLEUM CONTAMINATED SOIL UNDER THE DIRECT SUPERVISION OF FARALLON CONSULTING. FARALLON WILL PREPARE AN ENVIRONMENTAL MEDIA MANAGEMENT PLAN (EMMP)/CONSTRUCTION MANAGEMENT PLAN (CMP) WHICH WILL INCLUDE SOIL SEGREGATION AND HANDLING TO PREVENT SPREAD OF CONTAMINATION.
