## **EXECUTIVE SUMMARY**

This Sediment Management Plan (SMP) update amends the 1999 SMP (King County 1999). The 1999 SMP evaluated remediation alternatives for seven sediment cleanup sites located near King County combined sewer overflows (CSOs). The current SMP Update identifies appropriate sediment management strategies adjacent to each remaining King County CSO outfall location. Sediment quality at other facilities is evaluated on a case-by-case basis in separate reports. This SMP update describes King County CSO discharge locations, summarizes ongoing and previously performed sediment cleanup work, and summarizes the results of CSO solids deposition modeling and existing sediment quality in the CSO discharge areas. This SMP update also evaluates alternative sediment cleanup options for the University Regulator Station (RS) Overflow area to understand potential cost implications of any cleanup required at the site in order to incorporate into long-range planning.

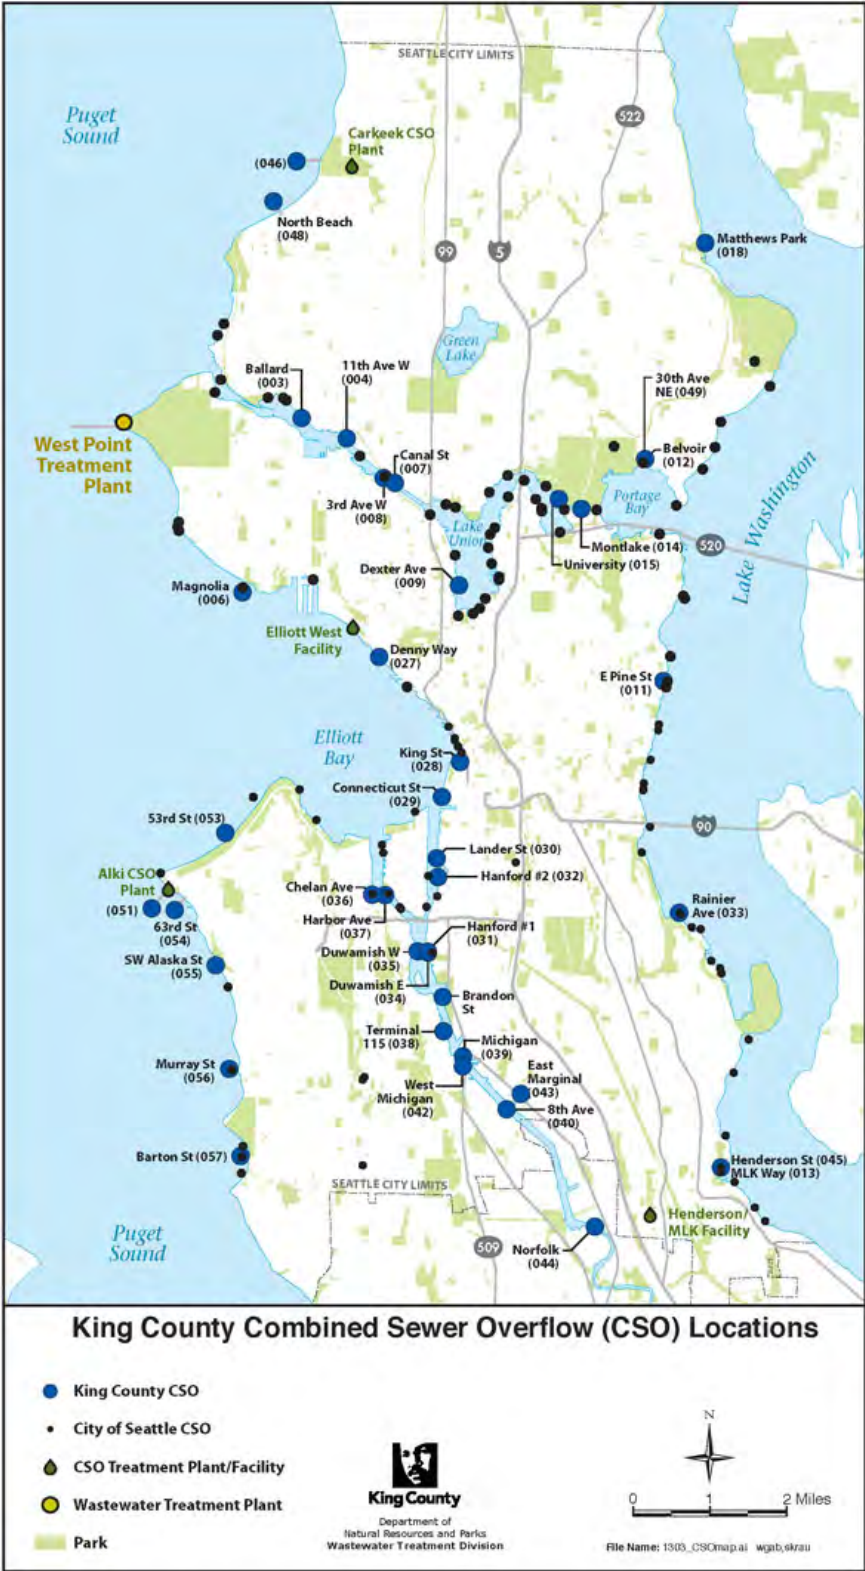
Figure ES-1  
King County CSO Discharge Locations

This SMP update has been developed by King County's Sediment Management Program in coordination with the CSO Control Program. CSO discharges have been reduced substantially in the last 20 years with significant CSO control capital projects and reduced loadings to the CSO system via upland land use changes and chemical management practices. However, persistent contaminants in sediments in some locations continue to pose a potential risk to aquatic life, wildlife, and human health. Figure ES-1 shows the King County CSO discharge locations.
